Olifants Rest Camp, Kruger National Park

Access for Guests with Mobility challenges

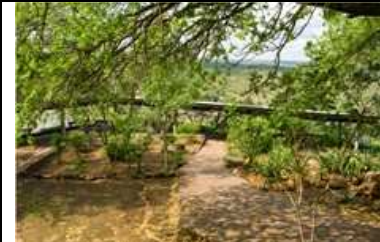
The highlight of Olifants is the river lookout (above right) and to get there is a wheelchair there is a choice of three pathways (shown below) which are all quite long and descend quite a way. Their respective gradients and smoothness of surface varies.

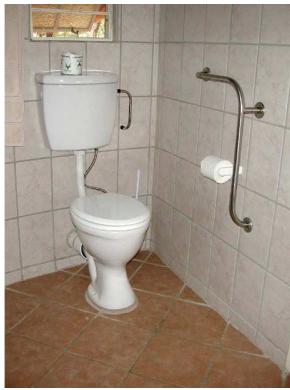
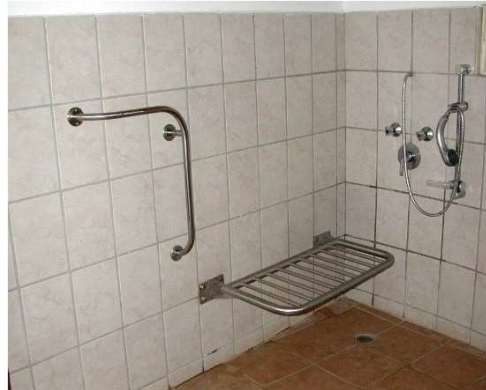
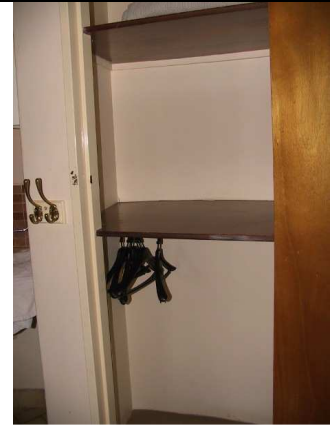
Accessible Accommodation in Olifants - Bungalow 76 (left) – for many years bungalow 76 was the only accessible accommodation unit at Olifants and for some inexplicable reason was fitted with a sunken bath with grab rails. Even for strong and mobile wheelchair users it was a challenge to use this facility which is in the centre of camp and has limited self catering facilities.

The good news is that during 2010 the camp finally removed the bath and replaced it with a roll-in shower (below centre). Unfortunately the contractor has put the supporting rails in the wrong place and the sliding pole for height adjusting the shower is positioned way too low, which will make it uncomfortable for standing persons who will still be the majority users of the unit. During the renovation they also retiled the unit and reattached the toilet grab rail (below left) in the incorrect position rendering it of little use. There is also no basin within reach of the toilet or a supporting rail at the rear of the toilet. Not a job well done, but still preferable to the sunken bath! One nice feature of the unit is the wardrobe, which has a hanging rail at a low (almost too low) level easy to reach for someone in a wheelchair.

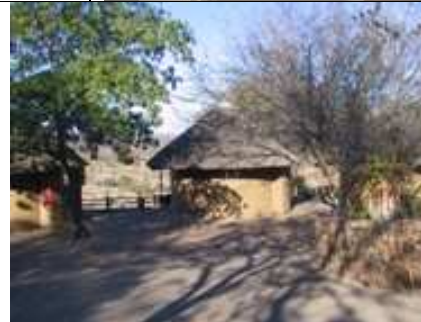
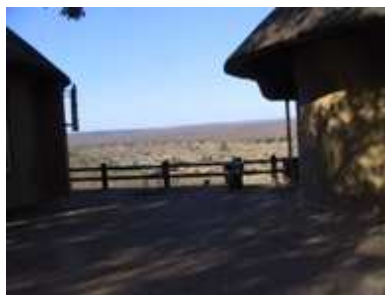
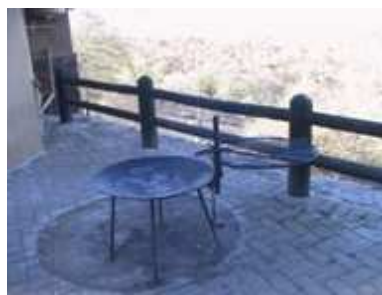
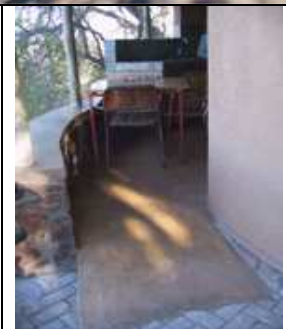
The camp now has a second accessible bungalow – one of the highly desirable **river view unit** (bungalow 7), however this unit is also fraught with inappropriate facilities! The parking outside the unit is sufficiently flat and wide (below left) and the braai facility (below centre) adjacent the unit can also be accessed no problem. But the access ramp onto the unit's veranda (below right) is quite steep and the table on the veranda (which has good clearance beneath it) may have to be shifted to create room to pass.

The kitchenette facilities on the veranda are semi accessible. No clearance has been provided below the hotplates (far left) or the sink (left) as both have cupboards beneath them meaning a wheelchair user must position their chair sideways and stretch to use the facilities.

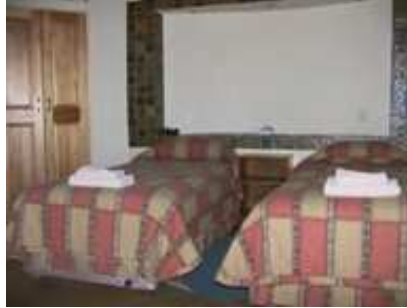
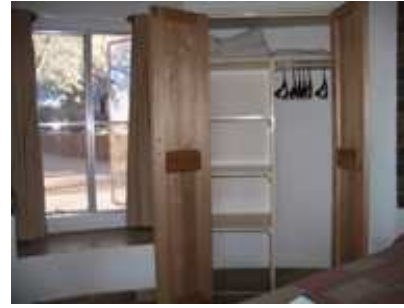
To access the bedroom chamber from the veranda a sliding door (below left) must be traversed. A small ridge at the base of the door frame may challenge some wheelers. Inside the chamber has 3 single beds (a third is to the right of the photo shown below) and the wardrobe (below right) is easy to access from a chair. There are remote controlled air-con and bedside light switches.
