Shingwedzi Camp – Access for Guests with Mobility Challenges

Shingwedzi Camp – Nxanatseni Region, Far Northern Kruger National Park

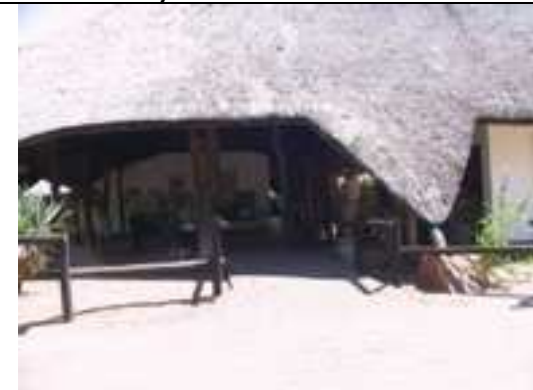
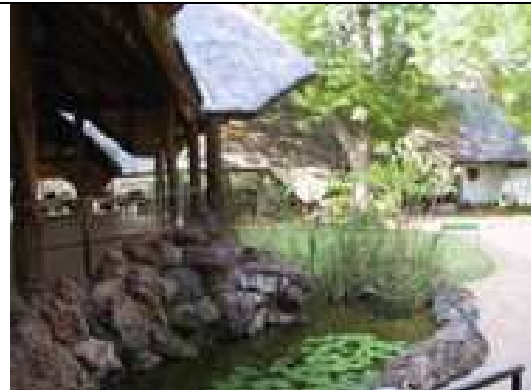
The camp's main complex also has adequate open-plan parking and the entire complex is ramped throughout to provide easy access to reception, shop, restaurant and tables overlooking the adjacent river. There are accessible ablutions in the men's and ladies ablutions

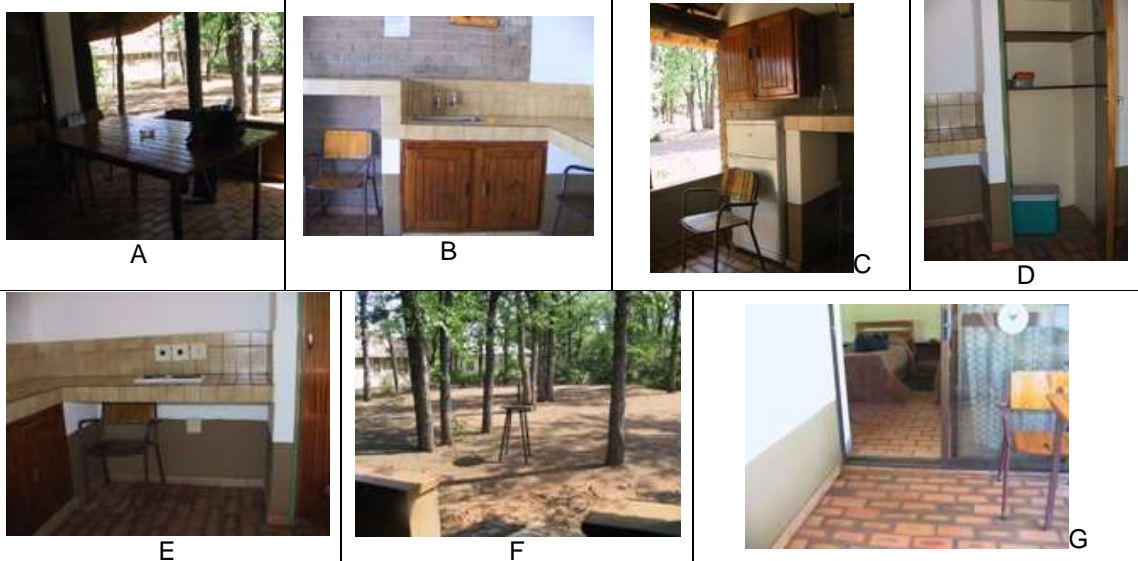
The units, like most Kruger units, are self catering, and once a person is up the ramp and onto the outside veranda there is a combination of good and bad accessible features. The overall space is good, although the table and chairs (which are easily shifted) takes up most of this space. The table (A) has excellent clearance underneath. The sink (B) on the other hand has no clearance so wheelchair users will have to position themselves sideways. The unit's current fridge (C) is too tall for the space provided, so it is positioned below the cupboard where the crockery and glasses are stored. This cupboard is too high to be properly accessible anyway, but the fridge in the way further limits the access for everyone, but for wheelchair users in particular. There is an alternative pantry cupboard (D) which is easily accessed and occupants should move or get staff to move stuff to this location. The hotplates (E) have great clearance. The outdoor braai (barbecue) stand (F) is also easily accessed, but like the route from the parking to the ramp, the soft sand can be a hindrance. Lastly the entrance into the units' bedrooms has a small ridge of a couple of cm which may impair some people in accessing the bedroom chamber.

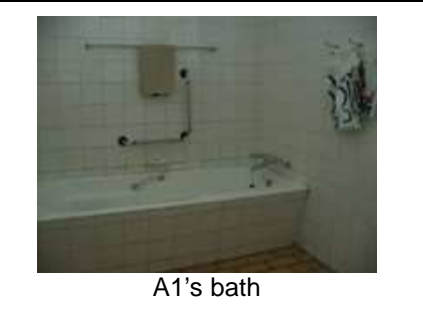
<p>A1's bath</p>

<p>The units' en suite ablutions are very spacious. The toilet's grab rails are well positioned, but there is no basin or water-supply within reach of the toilet!</p>	 	
<p>The baths in the 4 units are equipped with grab rails, but these are fixed in an inappropriate position in the centre of the bath and too high up the wall. The narrow rim of the bath towards the back of the tub is also a limiting feature for a person using this as an alternative to the rail during transfer. There is also no detachable hand-held shower set to aid people in the bath.</p>

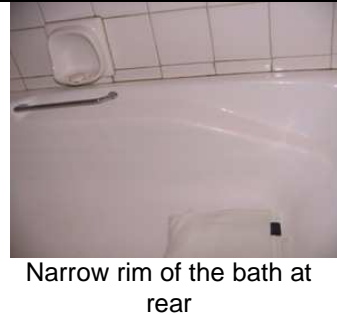
<p>Narrow rim of the bath at rear</p>
<p>Other accommodation: The remainder of the bungalows have no accessible adaptations. There are 12 huts which are fairly basic and rely on communal ablutions. There is a unisex accessible ablution with a roll-in shower and grab rails with the toilet in addition to the men's and ladies ablutions. The other communal ablutions servicing the camping sites did not have any accessible ablutions when last I checked, but that was several years ago and things may have changed.</p>
