Tamboti Tented Camp – Access for Guests with Mobility Challenges

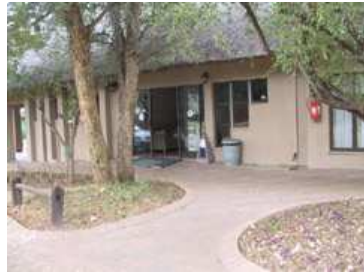
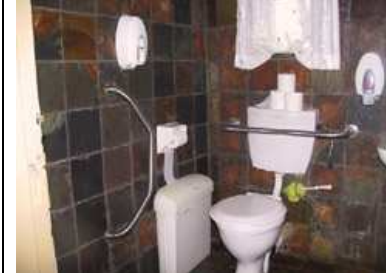
Visitors with reserved accommodation in Tamboti must first check in at the reception at Orpen Camp. Here there is a ramped entrance and a wheelchair ablution (where the grab rail on the adjacent wall needs repositioned!).

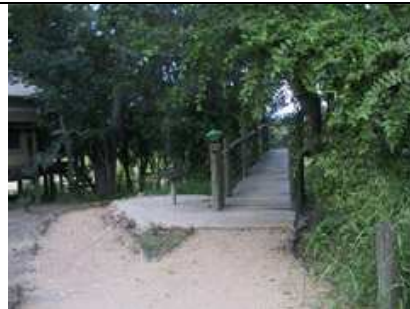
The ramp from the parking area is not too steep and the gravel from the parking to the ramp is compact, making mobility in a wheelchair easy. Heavy rain has meant a slight step from the gravel up to the concrete base of the unit. The braai (barbecue) facility is at the base of the ramp to the left of the image.

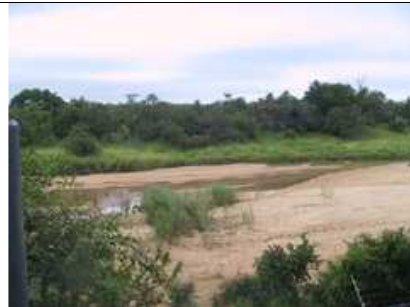
The unit's deck has a open plan kitchen and table all of which is easily accessible to a wheelchair user.

The deck also provides excellent views of the adjacent riverbed which hosts a steady stream of game that can be viewed from the comfort of the unit.
