Golden Gate Hotel – Accessibility to guests with Mobility Challenges, particularly those in wheelchairs

The following document reflects my thoughts on the accessibility of the new revitalized Golden Gate Hotel in Golden Gate Highlands National Park.

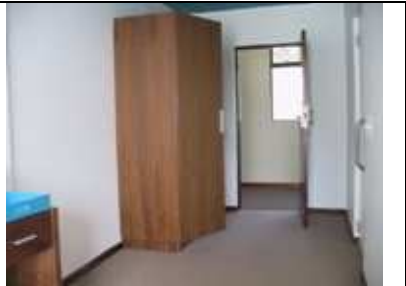
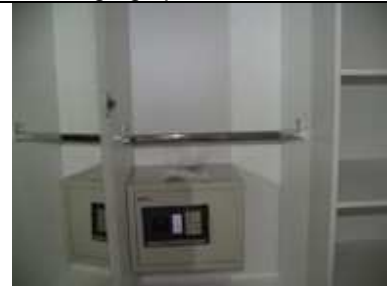
The **wardrobe** of room 53 (and all the other accessible rooms) is partially accessible, but efforts should be made to make it more so. The door of the wardrobe does not open fully, making it awkward for a wheelchair user to position themselves in a suitable position to access the interior. There is a full length mirror on the interior of the left hand door of the wardrobe, but for a person in a wheelchair to get to use it when the wardrobe door is open they have to reverse to where the door to the exterior of the room is. If the hinge could be extended to allow the wardrobe door to open wider it would make things much easier to access. Then the interior of the wardrobe has a dual rail in the interior hanging space (see below middle). The upper rail is out of reach for a wheelchair user, but the lower rail is in reach, although perhaps it is a little too low. A tall standing person will use the top rail for shirts and jackets, and the bottom rail for trousers. A wheelchair user will hang everything on the bottom rail, and if this bottom rail was about 20cm higher it would provide better hanging space for jackets and shirts. Then here's the rub, the room's safe has been placed below the bottom rail (see below right) and is compromising the hanging space a wheelchair user. The safe needs to be used and could easily be moved into the second lowest shelf immediately on the right of the hanging space.

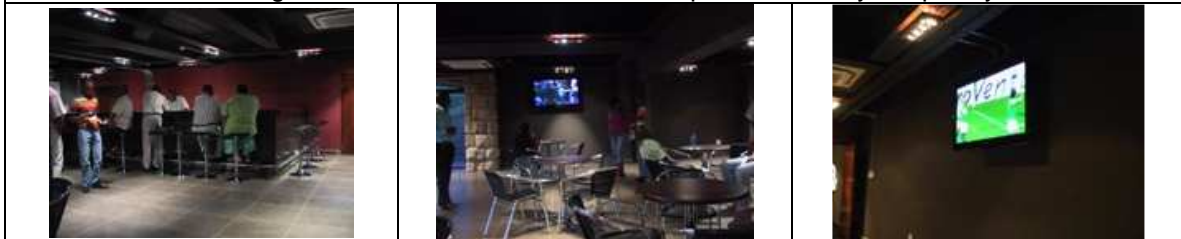
Level 1: Sport's Bar

Level 1 is where the sports bar is to be found and this is the only reason for any person, wheelchair user or not to descend to the basement level. The bar has an open layout with screens mounted on 2 of the walls, some tables and chairs in one section and a bar and bar stools in one of the corners. At the time of assessment some of the floor tiles immediately outside the lift were missing. Leaving a rough and uneven surface. There is apparently a problem sourcing the desired tiles, but I'm sure this problem is only temporary.
