## Karoo Access Profile as at March 2011:

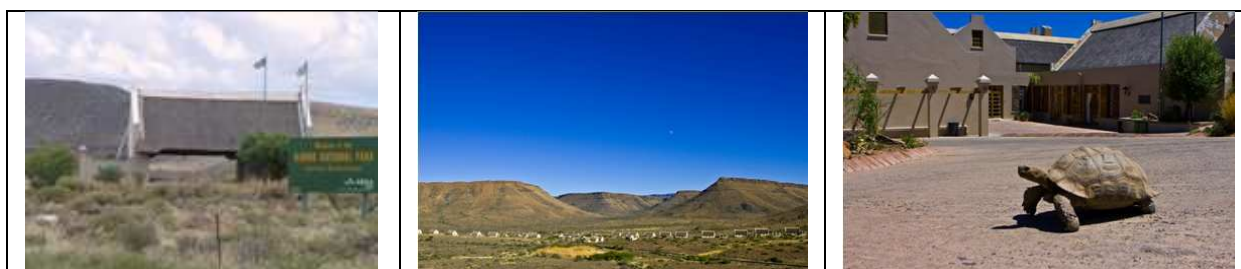
Mobility challenged drivers will not have to leave their vehicles at the park's entrance gate as the gate attendant will process the entrance permit through one's vehicle window. From there visitors make their way either to the park's main camp complex, 6 km away to check into their accommodation, or go on one of the park's self drive routes (scenic or game orientated). There is also a 4x4 route, but such visitors also need to check in at reception.

Karoo National Park's entrance gate, rest camp and reception building

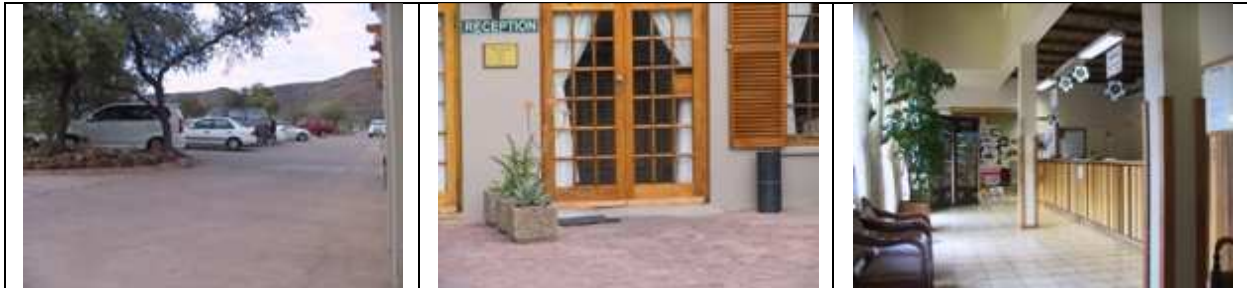
The parking at the park's main complex is open plan and on a slight slope. The park does plan to designate a wheelchair parking with sufficient width on level ground. There is a ridge at the entrance into the reception facility which some wheelchair users may not be able to negotiate without assistance. Inside the reception counter is all one level and there is not currently a lowered section for wheelchair guests.

Parking, reception entrance and reception desk

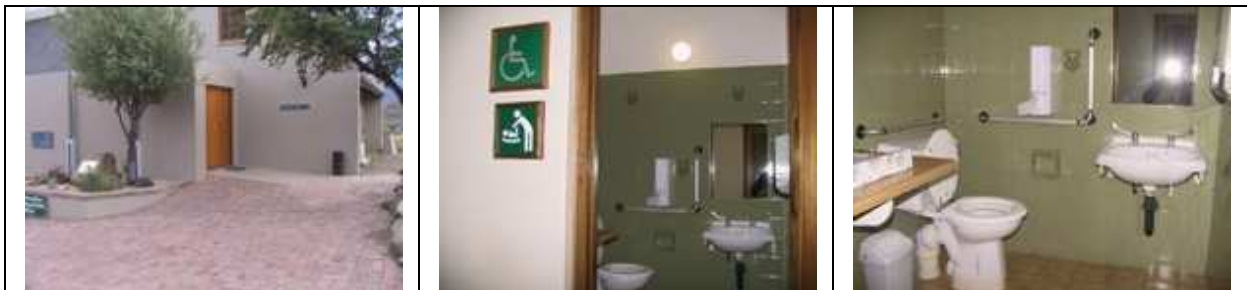
There are accessible public toilets at the main reception/restaurant complex, which meet the required standards.

Accessible public ablution and baby changer at park's main complex

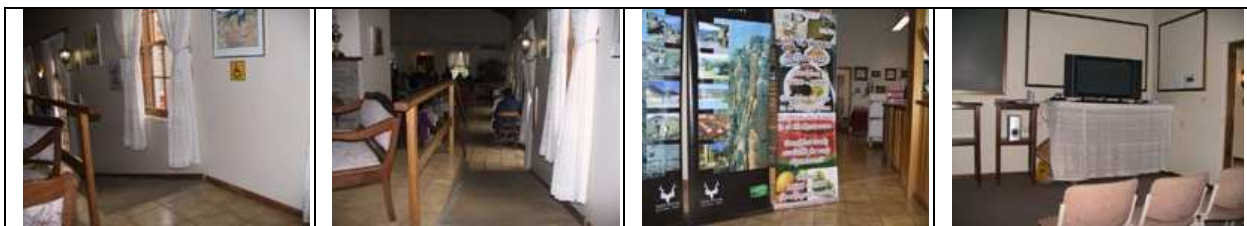
Inside the building the reception area, shop and meeting hall/audiovisual room are all easily accessible. The restaurant is accessed via a very steep ramp and assistance will be required to negotiate this.

Accessibility within the main complex building

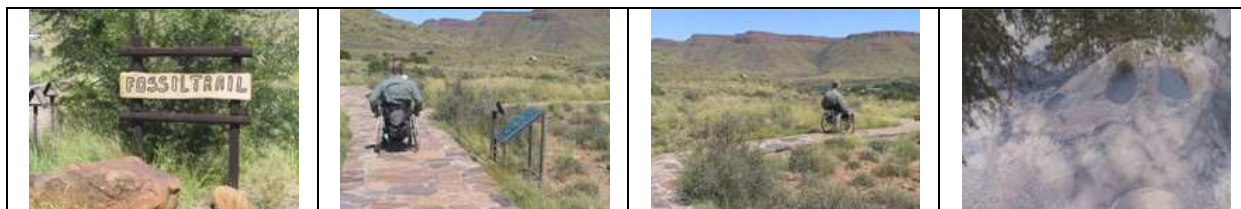
The park's main activity is self drive game drives. Since the reintroduction of lion in 2010 the self guided walks have been curtailed, but are still offered on a guided basis. However these are not appropriate for the mobility impaired, but there is a wheelchair accessible fossil trail in the main rest camp ...

Wheelchair accessible FOSSIL Trail

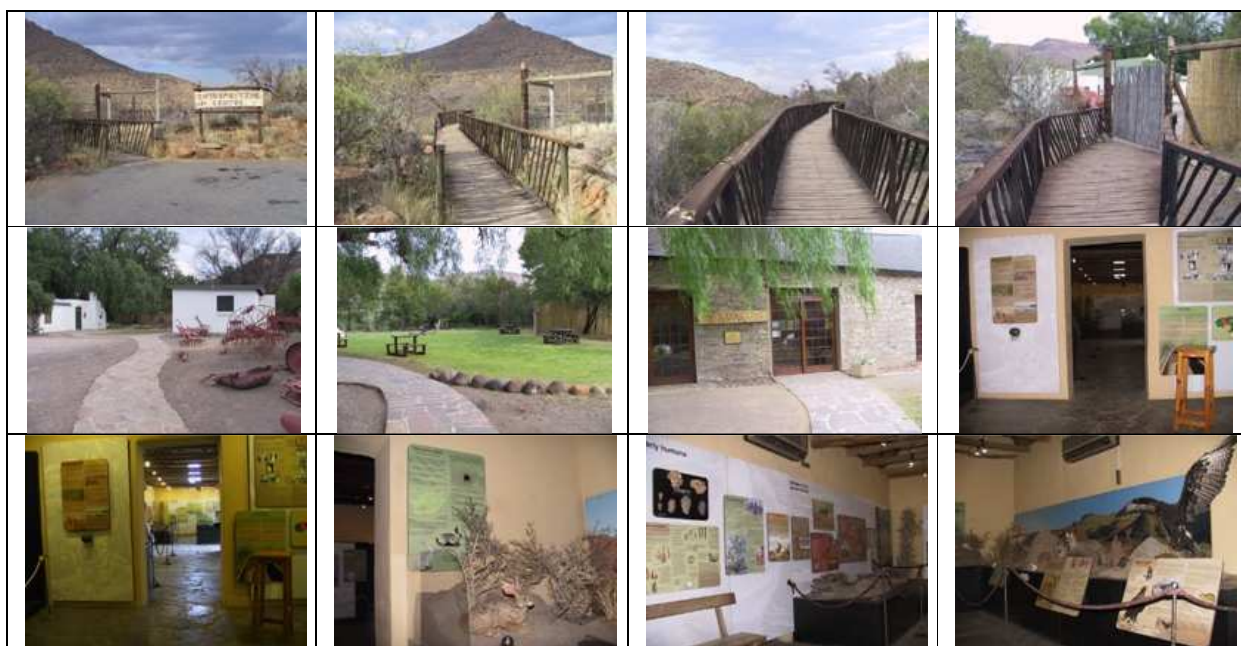
and the museum and information centre at Ou Skuur is accessed via a boardwalk alongside a dry river bed and then via a paved pathway. This exhibition gives visitors an insight into both the biological and cultural history of the park

Access to and in the Ou Skuur Info Centre

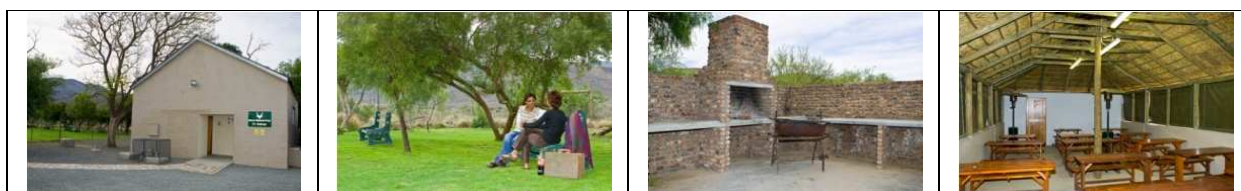
The picnic site and swimming pool at Bulkraal day visitor centre does not currently have any access adaptations, but is on flat ground. A bird hide near the main camp is not an accessible option.

Bulkraal Day Visitor Centre

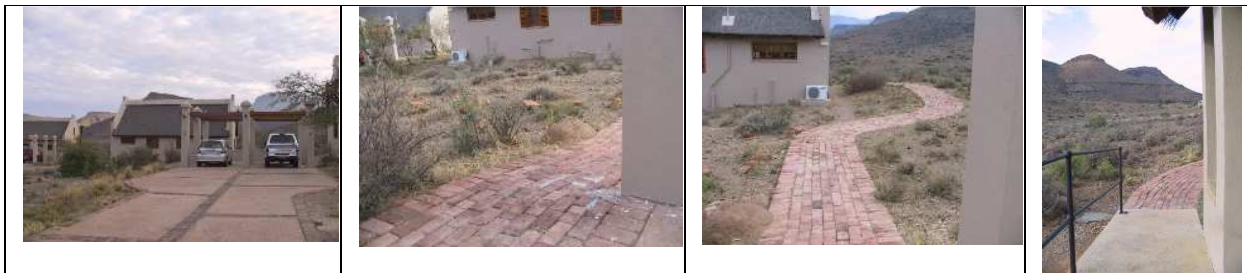
**Accessible Chalets:** The 2 three-bed accessible chalets' parking are relatively accessible. The parking area is flat and there is sufficient width for wheelchair users to move to and from their vehicle. There are some pillars flanking the parking zone which will need to be avoided when parking to insure they don't interfere with the open door where a wheelchair user must disembark. The pathway from the parking to the units is a little uneven and steep in places, but once one gets to the unit it becomes smoother and a support rail is provided to prevent anyone going over the side of the ramp.

Karoo Accessible Chalets parking and access path

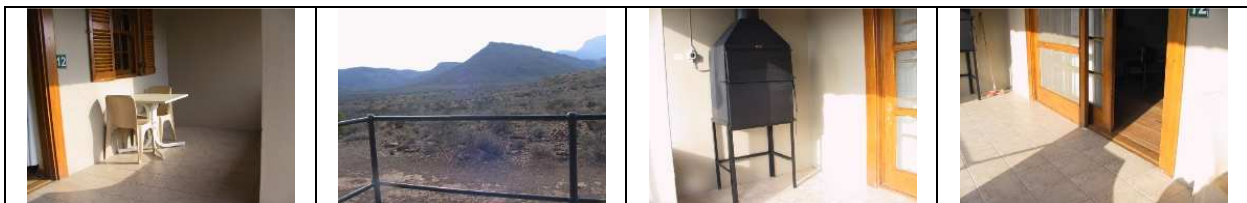
The veranda is flat and spacious and a rail provides safety for those admiring the view. The fold down braai is relatively accessible to use from a wheelchair. There is a ridge to get into the units' interiors which may challenge some in entering the unit which is done via a sliding door that does open a sufficient distance to accommodate wheelchair passage.

Karoo Accessible Chalet - veranda

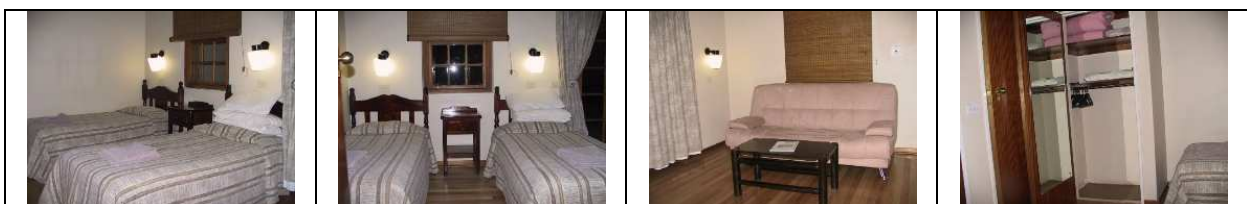
The open plan living area/bedroom area has 2 single beds, a sleeper couch and a wardrobe. All are fairly easy to access from a wheelchair.

Karoo Accessible Chalet – bedroom chamber

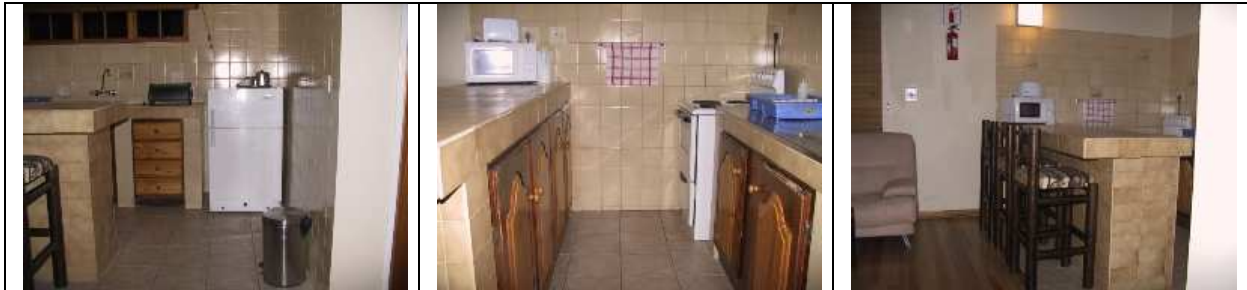
The kitchen is an open plan extension of the bedroom chamber and it does not have any adaptations for guests in wheelchairs such as clearance below the sink and hot plates. It is also somewhat cramped but there is space to manoeuvre alongside these facilities and the fridge can be accessed easily. The eating

bar is a little high for a person in a chair and perhaps when these units are next subject to refurbishment the kitchen can be adapted to be more accessible to guests in wheelchairs.

Accessible Chalet kitchen.

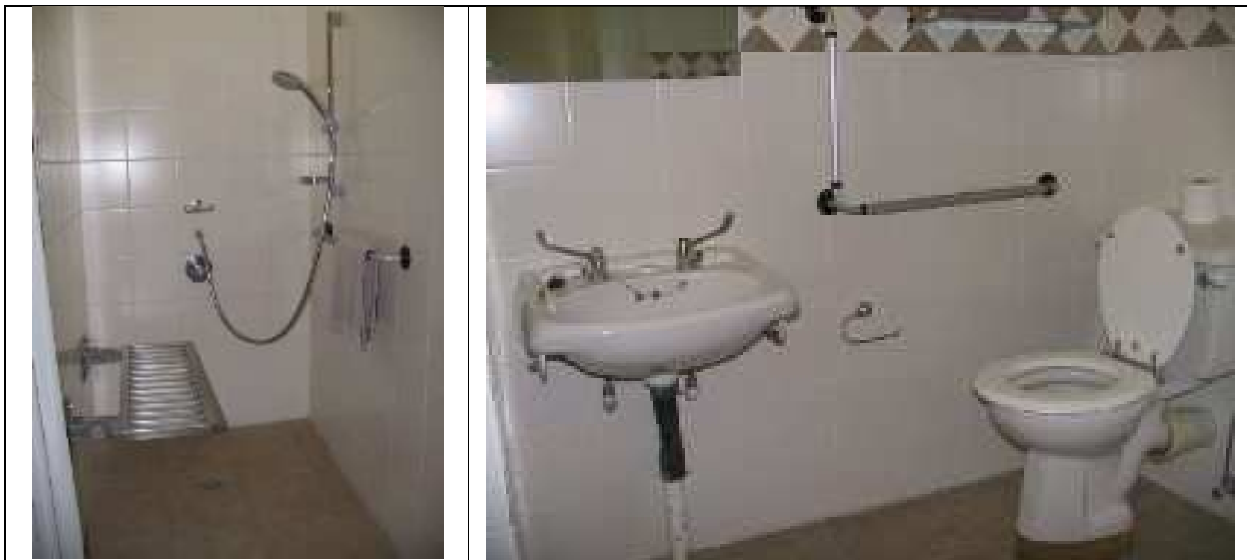
**Accessible Chalet Ablutions:** In the units' en suite ablutions there is a roll-in shower which although the fold down shower seat is an old design and no longer suitable compared to some of the latest products available, it is still an adequate surface size and most wheelchair users should be able to use the facility. The seat is a metal one and using a shower cushion or folded up towel is recommended to provide the necessary safety padding. The shower is detachable and can be adjusted in height for wheelchair users or their able-bodied travel companions. The units also have toilets with grab rails with sufficient space alongside to accommodate those requiring assistance during transfer. The basin has sufficient clearance and is fitted with lever taps. It is on the outer limits of being able to be reached by someone using the toilet, but otherwise most wheelchair users should find the ablutions suitable. The mirror could be tilted to be adjustable for people at a lower level.

Accessible Chalet ablutions

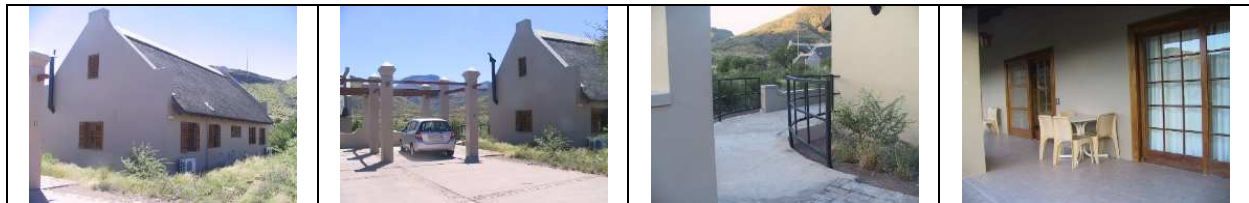
**Accessible Guest Cottage:** The accessible guest cottage has a similar parking set-up to the chalets, but the access path to the unit is much more accessible and the ridge into the unit is much more negotiable. The unit's veranda is a spacious flat area and entrance into the building and access to the fold down braai are both easily achieved in a wheelchair.

Karoo Accessible Guest Cottage exterior

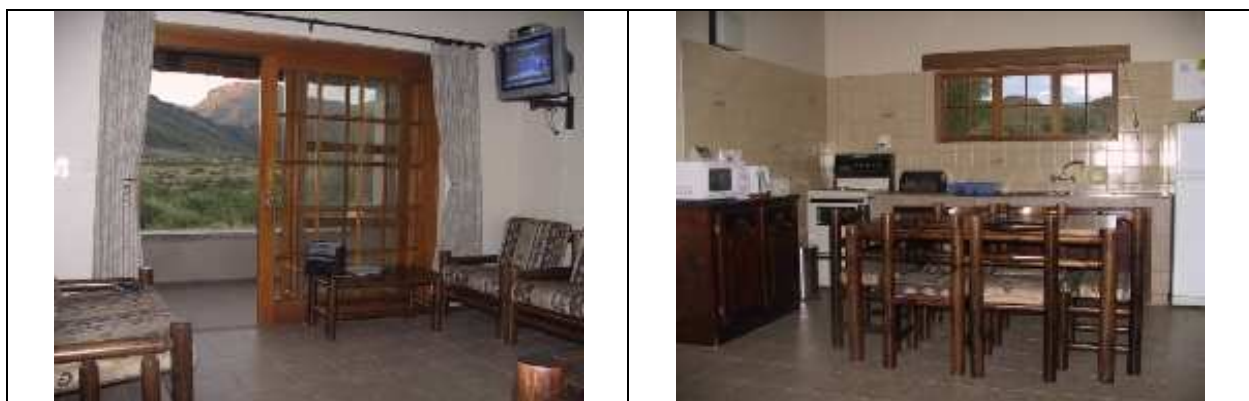
Inside the unit's open plan lounge/kitchen/dining area some furniture may need to be rearranged to provide seamless wheelchair access, but this is easily achieved. The same arrangement of chairs applies to the dining table. This table aside there the kitchen is relatively accessible although there is no clearance under the sink or stove.

The open plan lounge/dining/kitchen living space

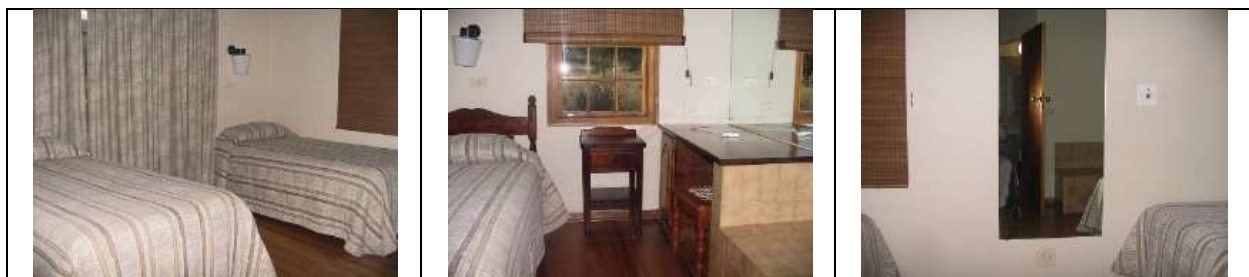
There are 2 bedroom chambers, both with accessible adaptations in their en suite ablutions, which are an inverse of each other. The bedrooms both have 3 single beds. Like the lounge furniture, the beds can be easily shifted when guests using the unit are in wheelchairs to place them in the most appropriate positions. Both bedrooms have an easily accessed full length mirror which is a refreshing feature and one of the single beds in each chamber is alongside a make-up station with adequate clearance beneath it to accommodate a wheelchair. This also makes a great work space for a laptop.

Bedroom East showing beds, mirror and make-up station.

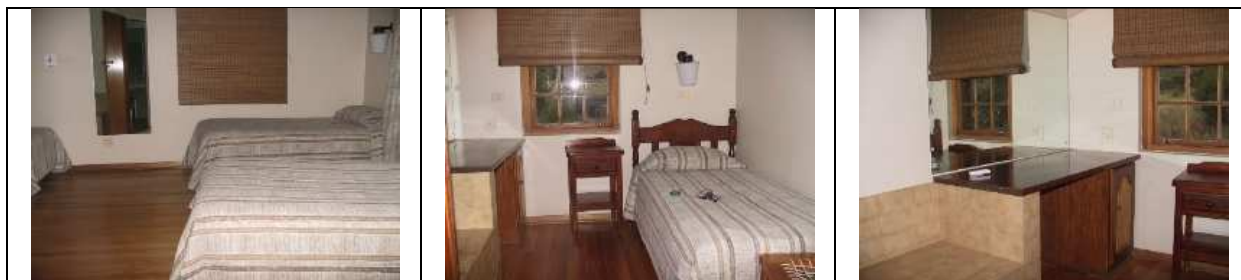
Bedroom West showing beds and make-up station.

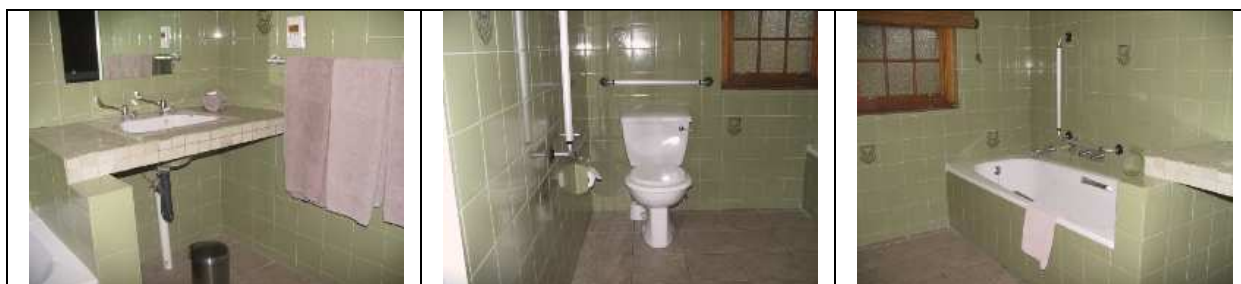
**Guest Cottage ABLUTIONS:** In the identical but inverse accessible en suite bathrooms, the basin set-up meets the necessary access specs with good clearance, lever taps and a well appointed mirror. The toilets have good and bad points in terms of their access. There is sufficient space alongside the toilets for a person to transfer or be transferred to and from the toilet. The rear grab rail is positioned correctly, but the adjacent one is positioned too far forward and the park management has been encouraged to shift it closer to the toilet to meet the required specs. There is also no basin or water supply within reach of someone using the toilet. However the ablutions' main shortcoming is the baths ... presently the units only have baths with grab rails. This will prevent many mobility challenges guests from using a facility that is designed with the intention of being accessible because they will not have the necessary strength to transfer to and from their wheelchairs into the bath. The park management has been encouraged to remove at least one of the baths and to replace it with a roll-in shower built to the correct specifications. Alternatively they have been given an option to add a fold down seat at the head of the bath and to insert a sliding height adjustable detachable shower on the wall to allow wheelchair users to transfer onto this seat and use the facility as a shower. Until the recommendations are realized the bath is also hampered for those strong enough to transfer into it because the grab rail is positioned too far forward

Bathroom East showing basin, toilet and bath

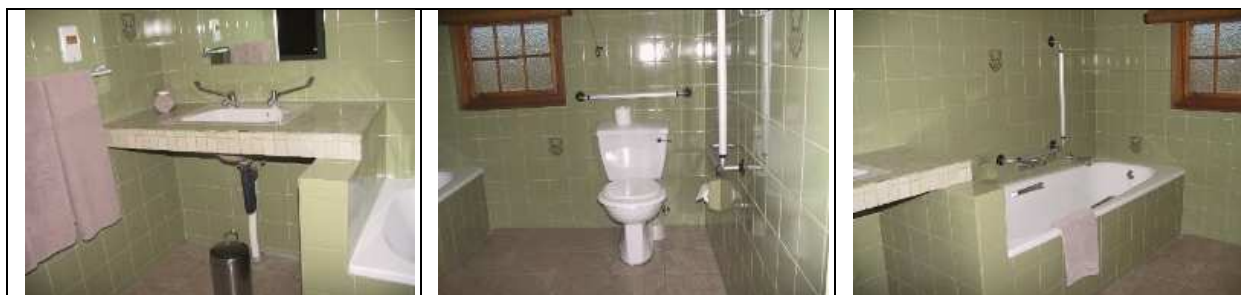
Bathroom West showing basin, toilet and bath

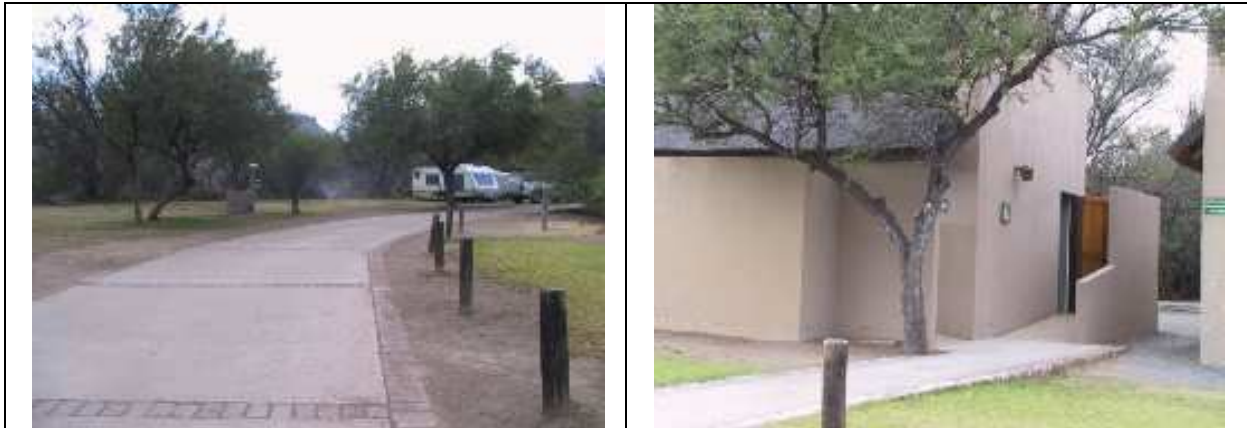
**Campsite Accessibility:** The park's campsite is generally adequately accessible. The designated area is all flat and while the sites are grassed, there is a concrete road that will facilitate movement from a site to the ablutions. There is a separate unisex accessible ablution which has a wide and level concrete access path culminating in a shallow ramp into the chamber.

Karoo National Park Campsite

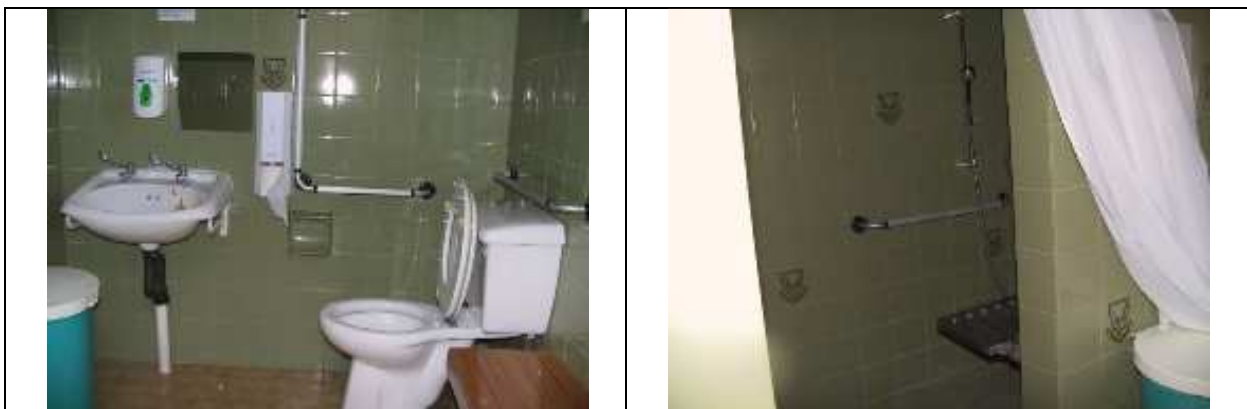
The ablutions have a toilet and basin that both meet the necessary specs for use and the basin is within reach of someone using the toilet which is always ideal. The roll-in shower is a little cramped being in a confined alcove. The toilet seat is an old design metal job and should be replaced with a more modern one meeting the size and composition requirements when next the park does maintenance to the facility.

Karoo National Park Campsite Ablutions
