## Namaqua National Park Access for Mobility Impaired Guests

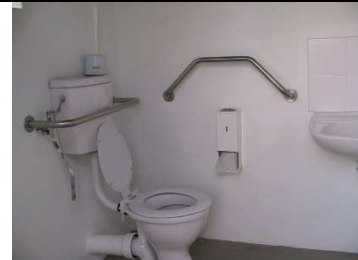
**ACCESSIBLE ABLUTIONS**

The reception offices and information centre also have public toilets, with one of them adapted to be accessible to guests in wheelchairs. There is a concrete path and a ramp that leads to this ablation block making it easy to navigate the sandy ground. The ablation is very spacious and there are grab rails behind and adjacent the toilet. The rail adjacent the toilet needs to be repositioned as it is not currently much use in its current position.

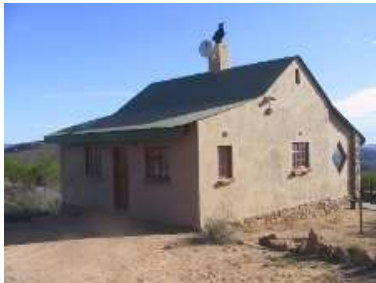
Skilpad Rest Camp Chalet 3

Although the designated accessible unit is relatively accommodating to guests in wheelchairs, there are a few areas of concern that need to be resolved and the park management has been briefed accordingly to address these issues. The first is at the entrance. The concrete ramp has eroded somewhat and there is now a ridge to negotiate. A more suitable ramped entrance needs to be provided.

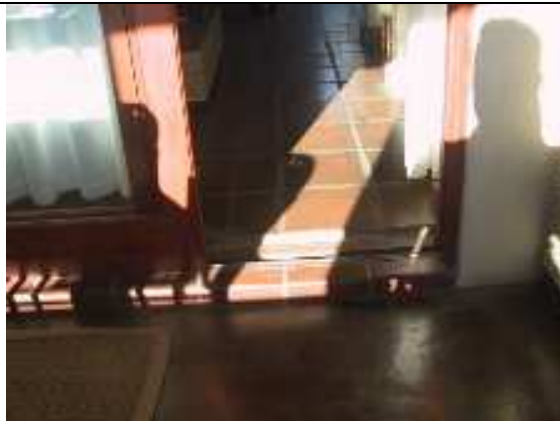
From the kitchen a person can either move into a sitting area (there is a sleeper couch, and arm chair and DSTV), or go into the ablutions or the bedroom chamber. Both the sitting area and the bedroom chamber lead out (separately) onto an enclosed veranda and both have a 10cm step down to that level. This is unacceptable in a facility intended to be for use by guests with mobility impairment and if permanent ramps are not inserted acquiring a portable ramp that can also be

Step from veranda into TV Room/Kitchen Area

used at the front entrance is a viable solution.

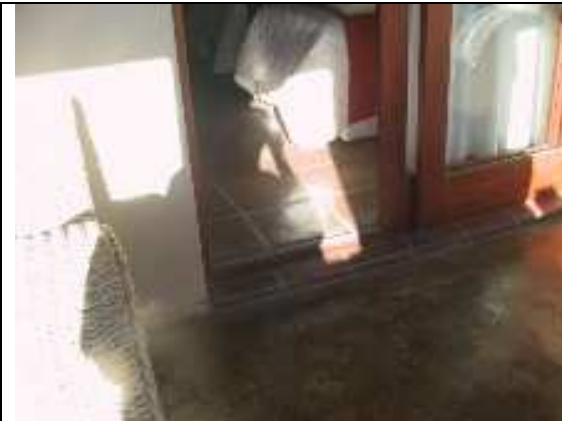
Step from veranda into bedroom chamber

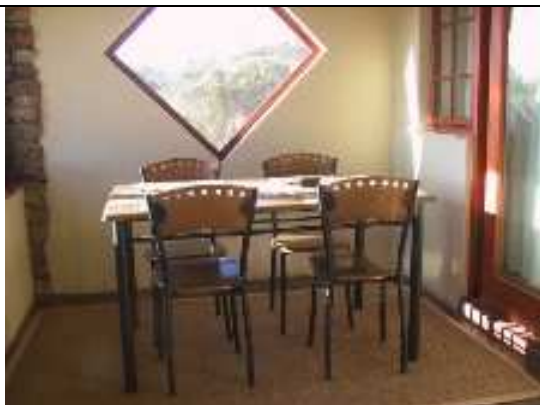
The dining area is currently difficult to access in a unit that is intended to be universally accessible

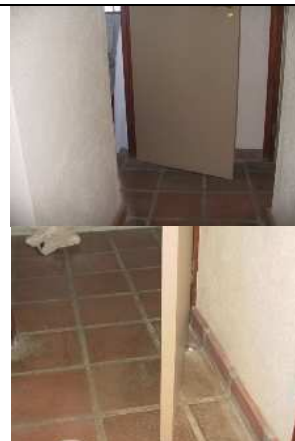
While the access to the veranda is compromised by steps, the access to the bedroom chamber and ablutions is compromised by a badly designed tight corner and a door stopper that prevents the bathroom door from opening fully. This means that a wheelchair user cannot move directly between bedroom and ablutions, but has to close the door and enter from the kitchen side. Removing this stopper will not be difficult and will improve the situation.
