VOLUME 1
**REPORT ON A GEOTECHNICAL SURVEY ALONG PROPOSED
NEW SHANGONI GATE ACCESS ROUTE,
KRUGER NATIONAL PARK**

REPORT REF.: LL3391

BY: P.G. Hansmeyer *Pr. Sci. Nat.*

DATE: September 2019

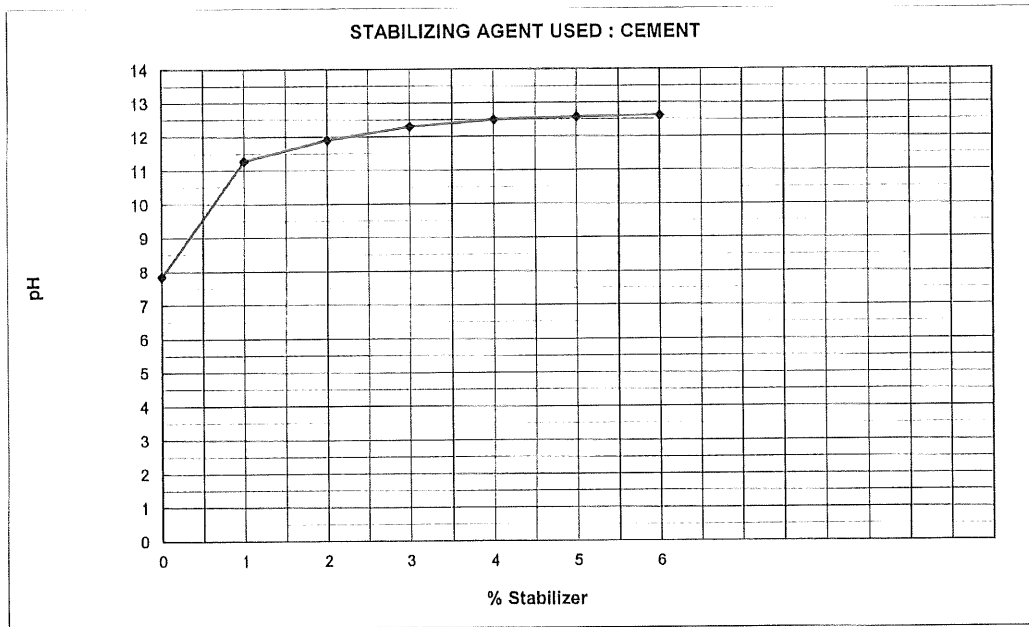
REMARKS: After 1 Hour

Recommended Cement Demand: 3.0%

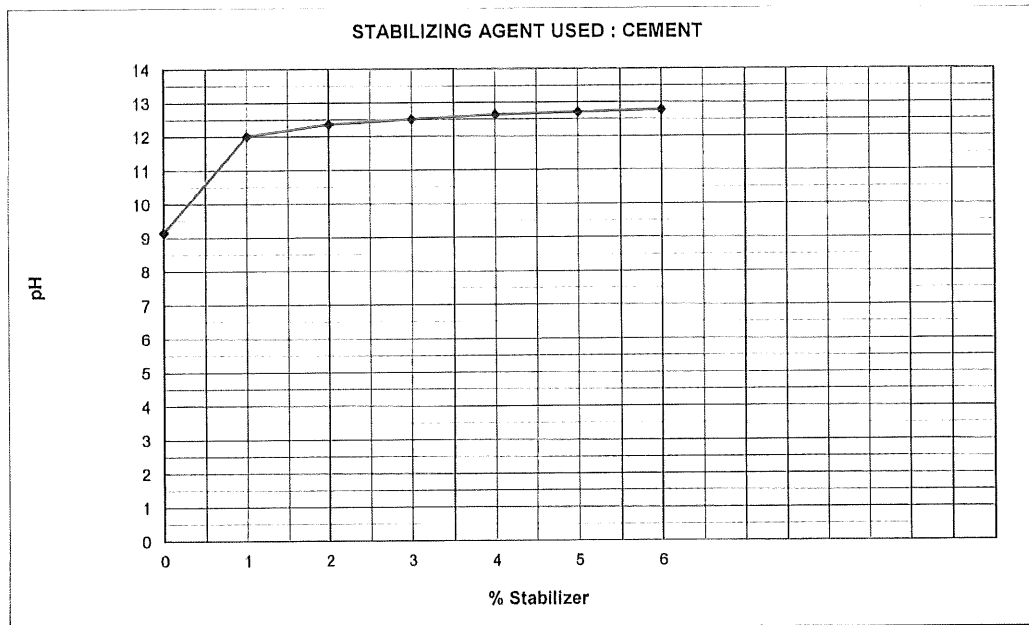
REMARKS: After 1 Hour

Recommended Cement Demand: 2.0%

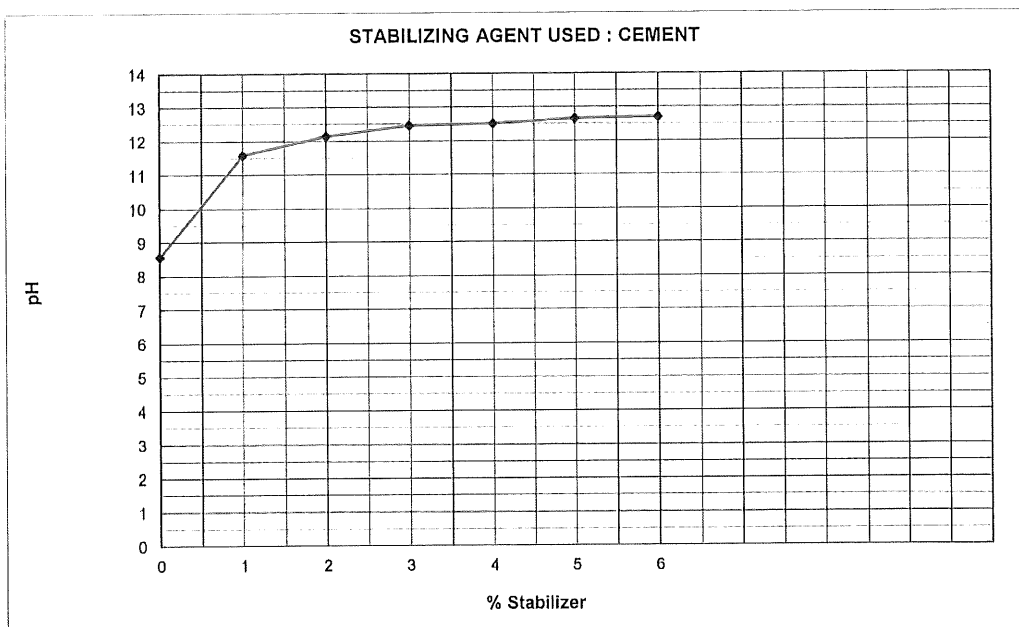
REMARKS: After 1 Hour

Recommended Cement Demand: 2.0%

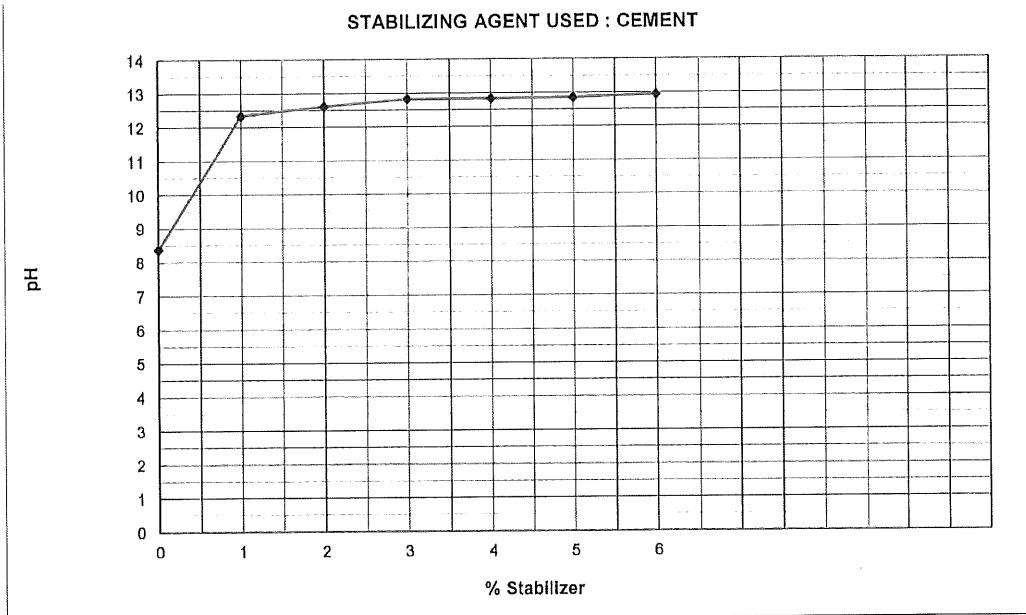
REMARKS: After 1 Hour

Recommended Cement Demand: 2.0%

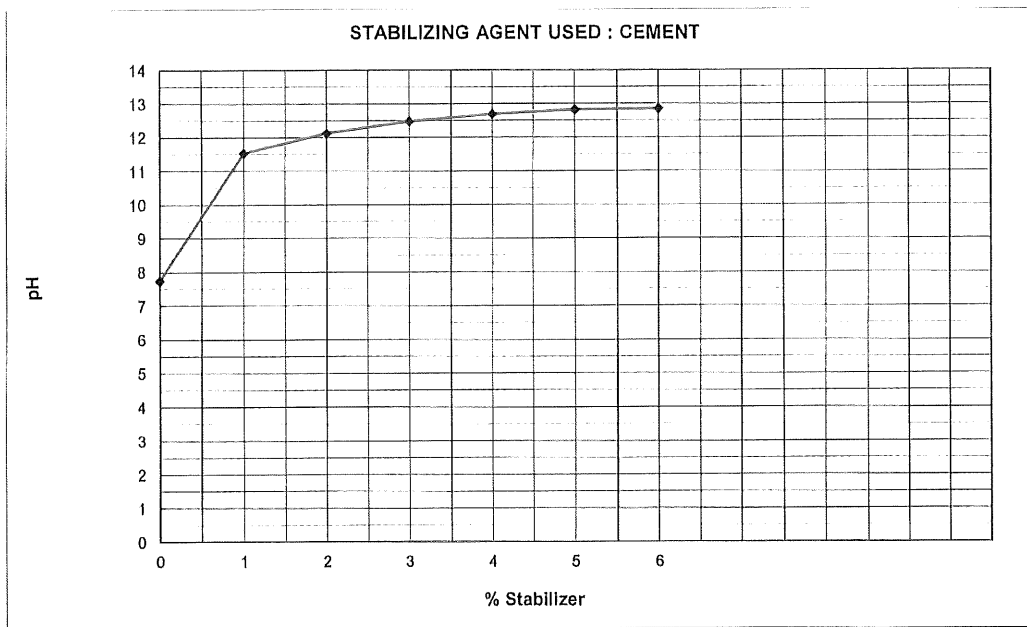
REMARKS: After 1 Hour
 Recommended Cement Demand: 2.0%
 pH of Cement: 13.14
 Temp: 24.6°C
 Supplier : CLIENT
 Cement type: Larfarge Cen IV B-V 32.5N

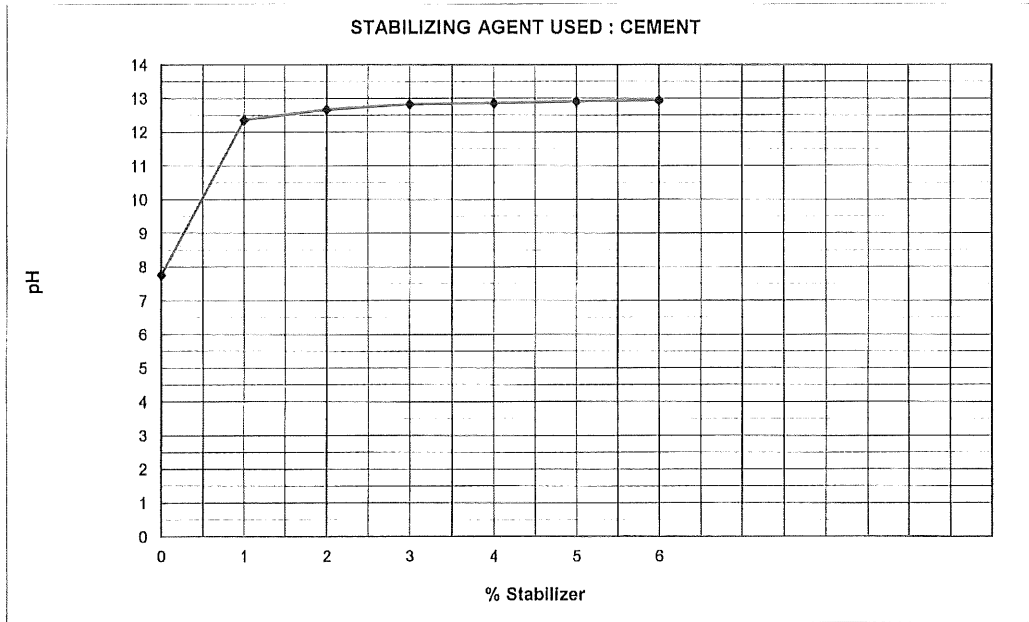
REMARKS: After 1 Hour

Recommended Cement Demand: 2.0%

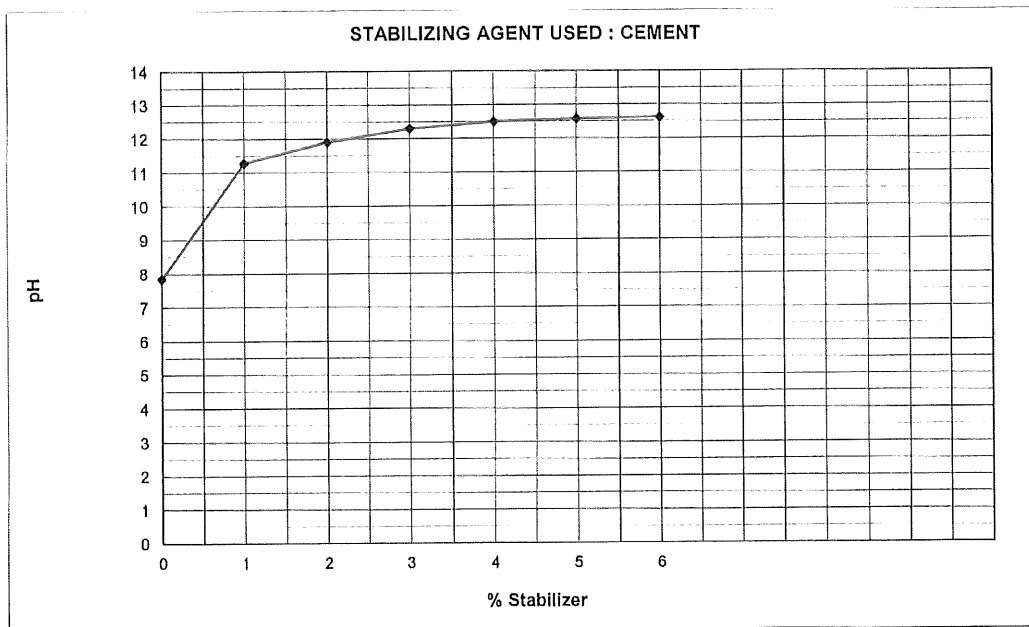
REMARKS: After 1 Hour

Recommended Cement Demand: 3.0%

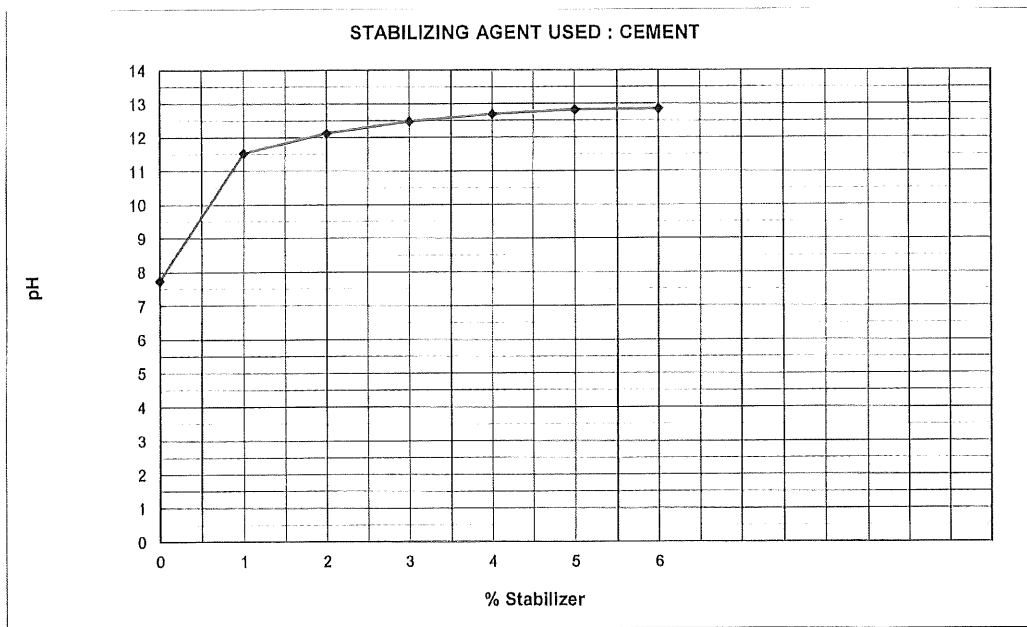
REMARKS: After 1 Hour
 Recommended Cement Demand: 2.0%
 pH of Cement: 13.14
 Temp: 24.6°C
 Supplier : CLIENT
 Cement type: Larfarge Cen IV B-V 32.5N
