**DOOR SCHEDULE:**  
**SANPARKS: PLATTEKLIP LOWER WASH HOUSE**  
**2502-500 – For Tender**  
**18.08.2026**

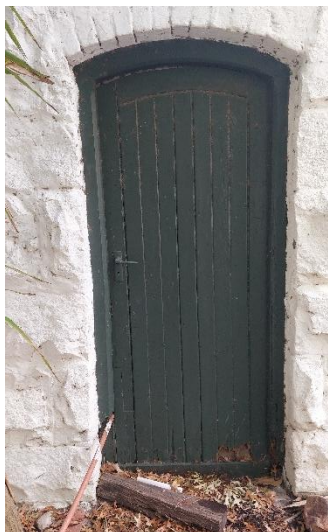
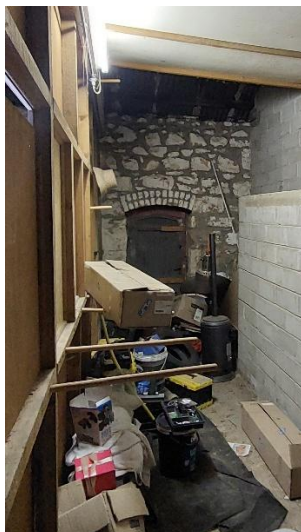
## DOOR 20

### Condition

**Frame:** Original. Base of frame rotten. Signs of previous repair.

**Door:** Original. Poor condition. 2 (off) original hinges. No bolt. One eye bolt to wall and original hook present.

**Frame:** Repair. Rotten base of frame to be cut 450mm above threshold in scarf joint pattern and replaced with new hardwood of a profile to match the existing. Seal around door frame externally with lime mortar. Sand and repaint door frame. Remove latch of new handle in frame and make good.

**Door:** Replace with new to match existing. Remove door and set aside for incorporation into possible exhibition. New door to be date stamped. Original ironmongery to be salvaged, repaired and reused. Install new bolt and eye bolt.

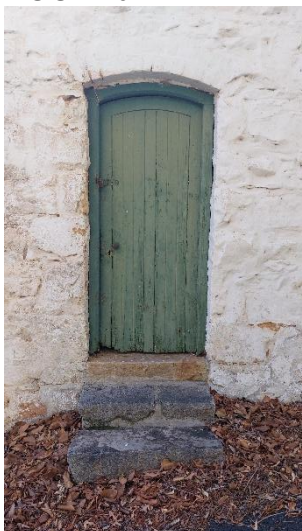
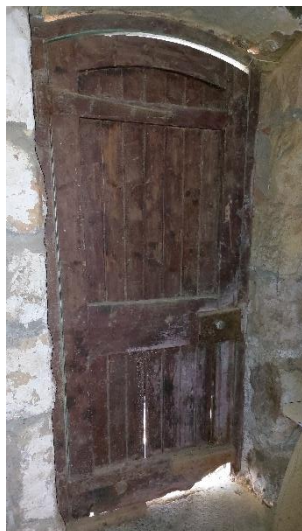
## DOOR 26

**Frame:** Original. Base of frame rotten.

**Door:** Original. Fair condition. 2 (off) original hinges. Ancient rim lock with JA Carpenter No.60 emblem and England Coat of Arms (c1830-1837 Manufacture). One eye bolt in door. Threshold piece and part of stile at base of door rotten. Base of battens on exterior rotten.

**Frame:** Repair. Rotten base of frame to be cut 450mm above threshold in scarf joint pattern and replaced with new hardwood of a profile to match the existing. Seal around door frame externally with lime mortar. Sand and repaint door frame. Remove hasp and staple and make good.

**Door:** Remove door, disassemble and repair. Repair rotten threshold piece, part of stile and base of battens. Reuse battens from Door 31 for repair. Sand and repaint entire door. Original ironmongery to be salvaged, repaired and reused. Carefully remove rim lock for refurbishment by specialist. Install new eye bolt and hook.

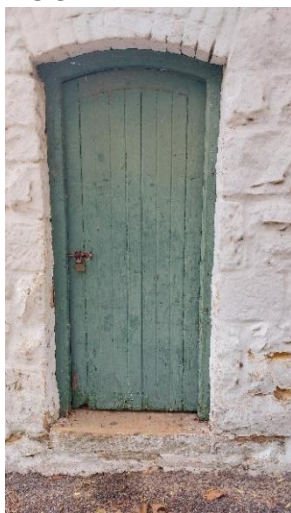
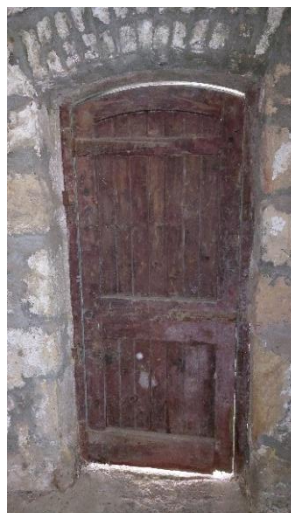
## DOOR 27

| Condition |
|---|
| <b>Frame:</b> Original. Base of frame rotten.<br><b>Door:</b> Original. Fair condition. Base of one of the stiles is rotten. Limited rot to base of battens on external face of door. 2 (off) original hinges. 2 sets of beam & brackets installed internally. One bolt, 2 (off) eye bolts. |

| Condition |
|---|
| <b>Frame:</b> Repair. Rotten base of frame to be cut 450mm above threshold in scarf joint pattern and replaced with new hardwood of a profile to match the existing. Seal around door frame externally with lime mortar. Sand and repaint door frame. Remove hasp and staple and make good.<br><b>Door:</b> Repair. Repair rotten base of stile. Limited rot to battens on external face of door to be removed and filled with epoxy. Sand and repaint entire door. Original ironmongery to be salvaged, repaired and reused. Install new hook. |

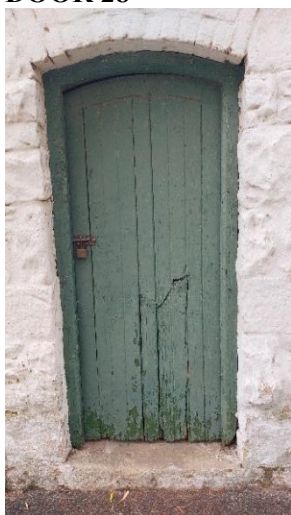
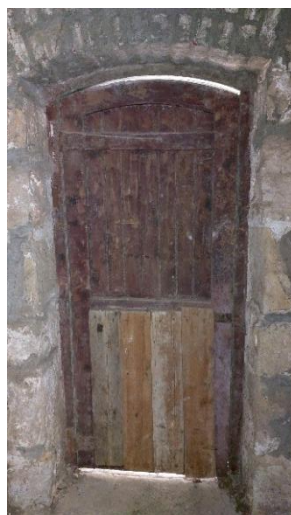
## DOOR 28

| Condition |
|---|
| <b>Frame:</b> Original. Base of frame rotten.<br><b>Door:</b> Original, contemporary repairs visible (boarding internally). Badly damaged. 2 (off) original hinges. 2 sets of beam & brackets installed internally. No bolt (one eye bolt in wall, part of hook visible) |

| Condition |
|---|
| <b>Frame:</b> Repair. Rotten base of frame to be cut 450mm above threshold in scarf joint pattern and replaced with new hardwood of a profile to match the existing. Seal around door frame externally with lime mortar. Sand and repaint door frame. Remove hasp and staple and make good.<br><b>Door:</b> Replace with new to match existing. Remove door and set aside for incorporation into possible exhibition. New door to be date stamped. Original ironmongery to be salvaged, repaired and reused. Install new bolt, eye bolt and hook. |

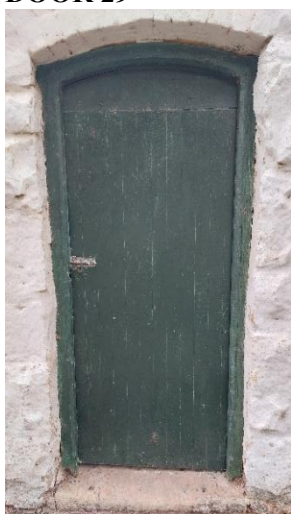
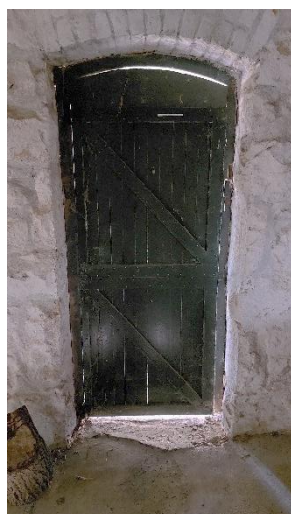
## DOOR 29

| Condition |
|---|
| <b>Frame:</b> Original. Base of frame rotten. Damage due to installation of lock.<br><b>Door:</b> Contemporary replacement. |

| Condition |
|---|
| <b>Frame:</b> Repair. Rotten base of frame to be cut 450mm above threshold in scarf joint pattern and replaced with new hardwood of a profile to match the existing. Repair damage to frame from installation of lock with profiled piece to match existing. Seal around door frame externally with lime mortar. Sand and repaint door frame. Remove hasp and staple and make good.<br><b>Door:</b> Replace with new to match original doors. New door to be date stamped. Replace ironmongery with new (of similar to original). Install new bolt, eye bolt and hook. |

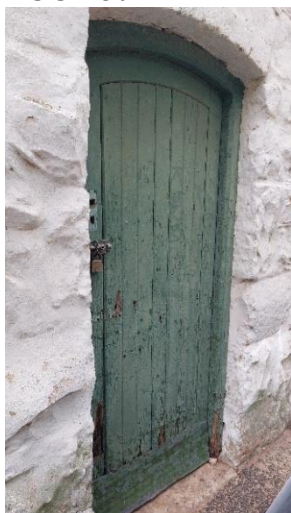
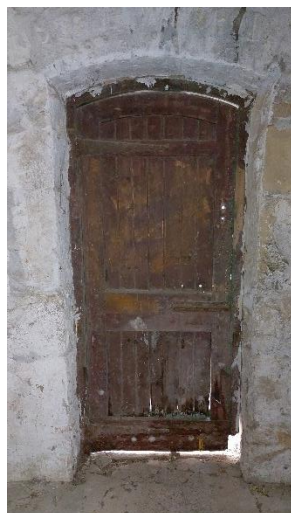
## DOOR 30

| Condition |
|---|
| <p><b>Frame:</b> Original. Base of frame rotten. Damage to frame where mortice lock forced.</p> <p><b>Door:</b> Original. Badly damaged. Signs of earlier repair evident (Sheet metal placed on base of door externally to cover rotten battens). 2 (off) original hinges. 1 set of beam &amp; brackets installed internally. One bolt, 2 (off) eye bolts, no hook.</p> |

| Condition |
|---|
| <p><b>Frame:</b> Repair. Rotten base of frame to be cut 450mm above threshold in scarf joint pattern and replaced with new hardwood of a profile to match the existing. Repair damage from mortice lock to frame. Seal around door frame externally with lime mortar. Sand and repaint door frame. Remove hasp and staple and make good.</p> <p><b>Door:</b> Replace with new to match existing. Remove door and set aside for incorporation into possible exhibition. New door to be date stamped. Original ironmongery to be salvaged, repaired and reused. Install new hook.</p> |

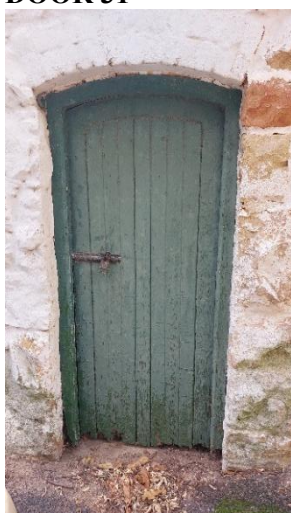
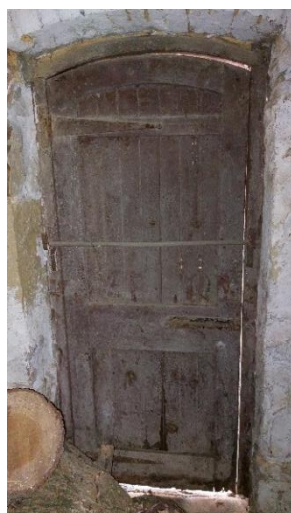
## DOOR 31

| Condition |
|---|
| <p><b>Frame:</b> Original. Base of frame rotten. Prior repairs visible.</p> <p><b>Door:</b> Original. Base of door badly damaged. 2 (off) original hinges. 1 set of beam &amp; brackets installed internally. One bolt, 2 (off) eye bolts, no hook.</p> |

| Condition |
|---|
| <p><b>Frame:</b> Repair. Rotten base of frame to be cut 450mm above threshold in scarf joint pattern and replaced with new hardwood of a profile to match the existing. Seal around door frame externally with lime mortar. Sand and repaint door frame. Remove hasp and staple and make good.</p> <p><b>Door:</b> Replace with new to match existing. Remove door and set aside for incorporation into possible exhibition. New door to be date stamped. Original ironmongery to be salvaged, repaired and reused. Install new hook.</p> |
