Skukuza Camp, Kruger National Park – Access for Guests with Mobility Challenges

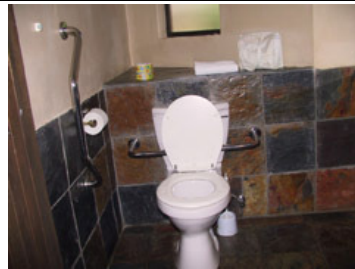
Luxury Riverside Bungalows - Two of these units have ramped access, grab rails next to the toilet and roll-in shower. Unfortunately there is no fold-down seat in the shower, so guests in wheelchairs may want to use one of the chairs from the unit's veranda. The units not only have a river view, but also have a limited channel television, as well as cooking and washing facilities.

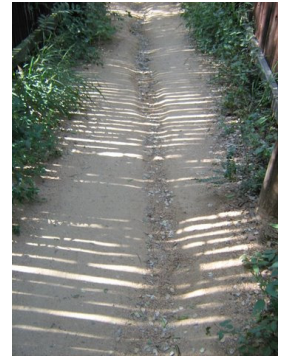
2km from the nursery and about 5km from Skukuza by road is the **Lake Panic Bird Hide**. Inside the hide there are gaps in the benches where wheelchair users can view from, although unlike some of the newer hides there is not leg clearance under the viewing slot. The pathway into the hide is sandy in places and is prone to erosion after heavy summer rain, and at times wheelchair users may require assistance, but with or without help it is ideal for close-up viewing of hippos, crocodiles, waterbirds and other wildlife.
