Letaba Bridge Camp, Kruger National Park

Access for Guests with Mobility challenges

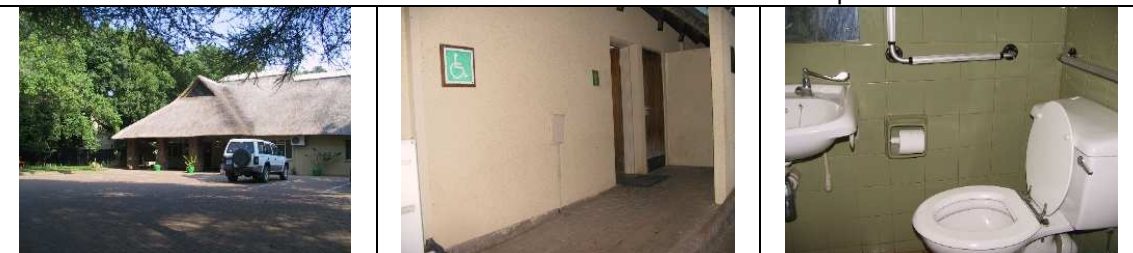
On arrival at Letaba, one checks in at the **reception building** (shown below left). There is no allocated parking bay for wheelchair users, but plenty of open parking and selecting a suitable place to disembark is usually not a problem. Access into the building is good. There is a **public ablution for wheelchair users** round the back of the reception block.

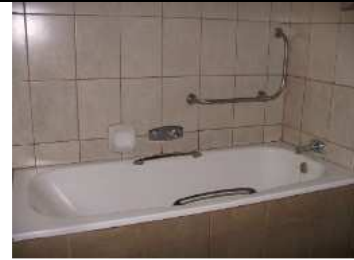
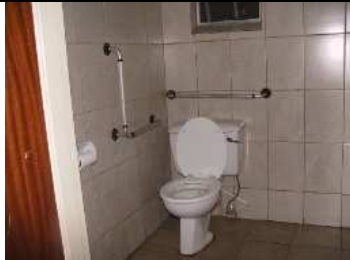
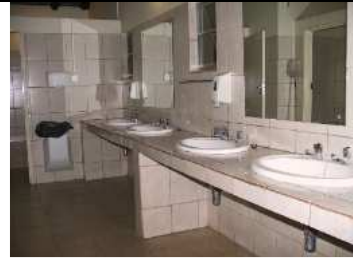
The ablutions are communal and shared with the **campsite**. To get there from the safari tents does require the negotiation of a curb with angled bricks (far left) and a small ridge at the entrance (left) to the ablation block (caused by erosion after heavy rains)

Unfortunately no roll-in-shower is available, but a bath with grab rails (without a detachable hand shower and with the rail in a poor position) is available as well as a toilet with grab rails. There is no basin within reach of the toilet which has its own private cubicle. The basins do have sufficient leg clearance, but no push style taps.

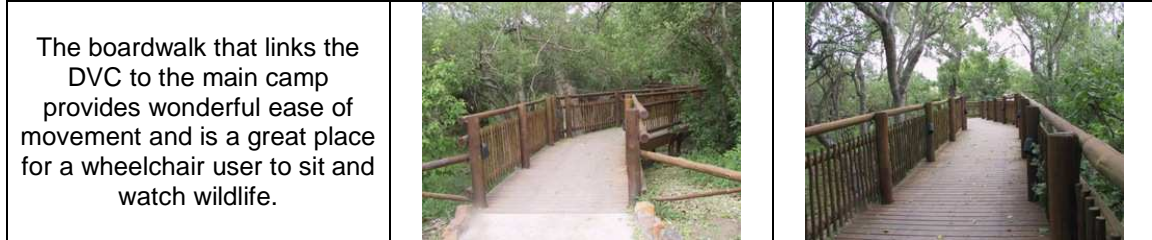
The **Letaba (Mbavala) Day Visitor Centre (DVC)** that adjoins the camp but is intended for use by non-residents of the camp is fairly new and offers fairly good access as the underlying pictures will show. A wide, firm and smooth pathway takes one from the parking area down to the facility. Among the picnic tables some of the paths are a bit gravelly.

The tables are not superbly designed to allow clearance for a wheelchair users legs, but with an angled approach can be used.
