Letaba Bridge Camp, Kruger National Park

Access for Guests with Mobility challenges

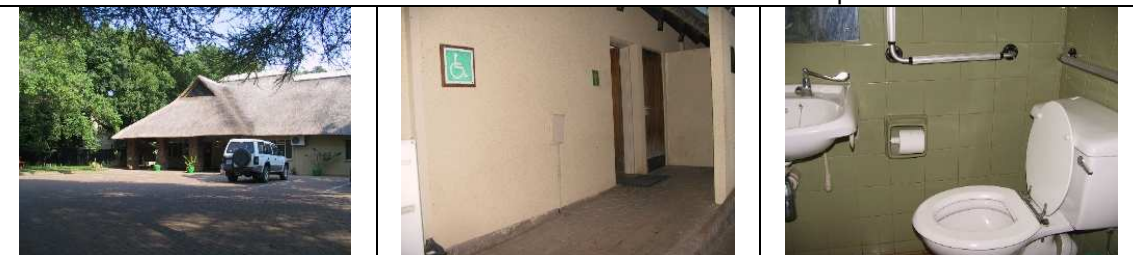
On arrival at Letaba, one checks in at the **reception building** (shown below left). There is no allocated parking bay for wheelchair users, but plenty of open parking and selecting a suitable place to disembark is usually not a problem. Access into the building is good. There is a **public ablution for wheelchair users** round the back of the reception block.

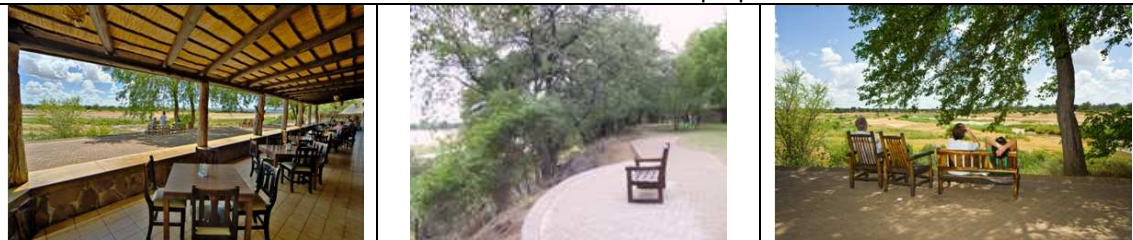
Most of the camp's **General Facilities** are easily accessed including the **shop, restaurant, cafeteria** and their accompanying deck which overlooks the river. There are no accessible ablutions inside the restaurant, but there is an accessible toilet and roll-in shower immediately east of the cafeteria some 20m away. The **riverside path** leading from the deck along the perimeter fence lends itself to a comfortable ride in a wheelchair and there are several lookout spots that make ideal places to sit, scan and listen. For the most part is on the same level as the camp, but it does descend down to the fence in 2 places and as there are steps this portion of the trail is not suitable for unassisted propulsion

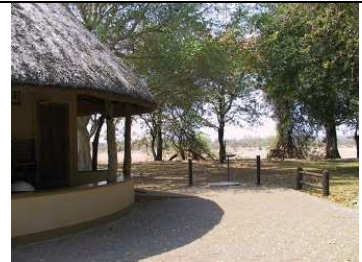
The two oldest adapted accessible units are the two **riverside bungalows with baths**. These have an awesome location overlooking the river (see right), and while roll-in-showers are a more appropriate type of accessible ablution, the units are otherwise fairly comfortable to use. They have ample parking space in front of the unit and a shallow ramp up into the unit.

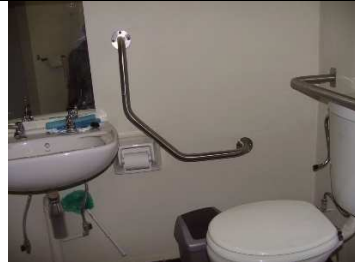
In the bedroom chamber, the bedroom is adequately spacious and all 3 beds can be accessed with ease. The air-conditioner is remote controlled. The wardrobe and shelf space are easy to reach from a wheelchair.

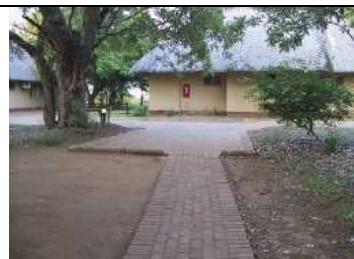
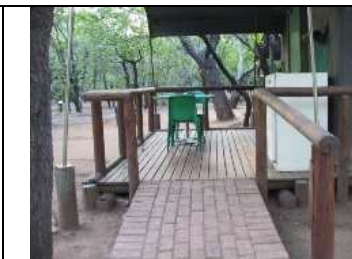
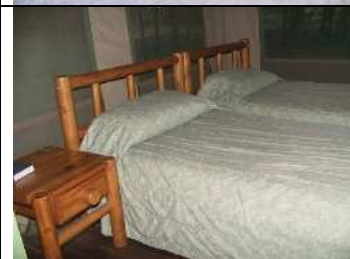
The **accessible safari tents** (the 2-bed one is shown here) have ramped access and the bricked pathways are ideal for ease of movement. The interior is basic but easy to move around in a wheelchair with the beds and cupboard easily negotiated.

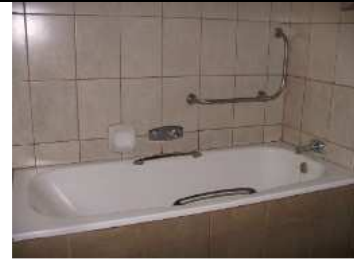
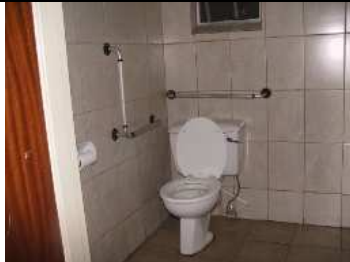
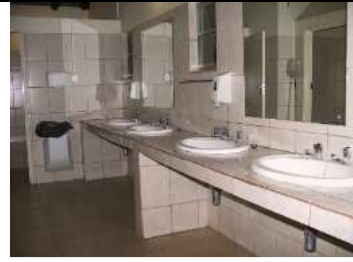
The ablutions are communal and shared with the **campsite**. To get there from the safari tents does require the negotiation of a curb with angled bricks (far left) and a small ridge at the entrance (left) to the ablation block (caused by erosion after heavy rains)

Unfortunately no roll-in-shower is available, but a bath with grab rails (without a detachable hand shower and with the rail in a poor position) is available as well as a toilet with grab rails. There is no basin within reach of the toilet which has its own private cubicle. The basins do have sufficient leg clearance, but no push style taps.

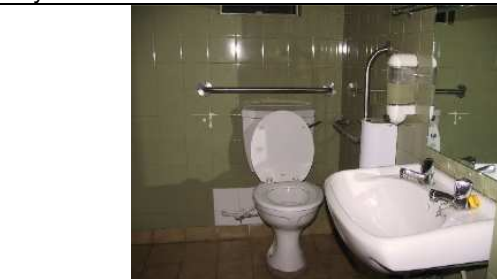
Alternate Accessible Ablutions: Bizarrely there is a communal roll-in-shower facility elsewhere in the camp. This little known and used accessible ablation facility next to the cafeteria is actually quite well designed as shown in the images below. The metal shower seat is out of date and could be replaced by one with stretch canvas.

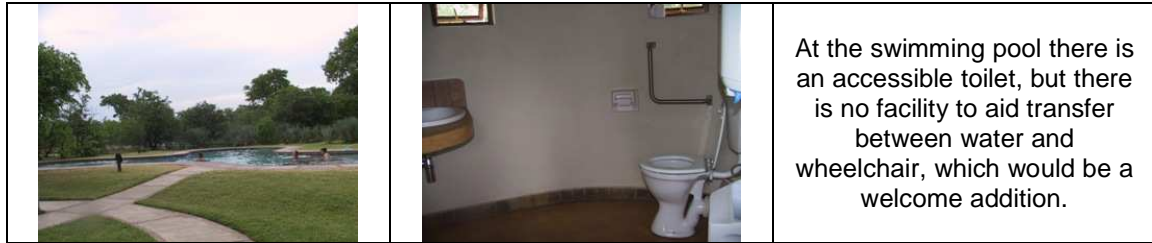
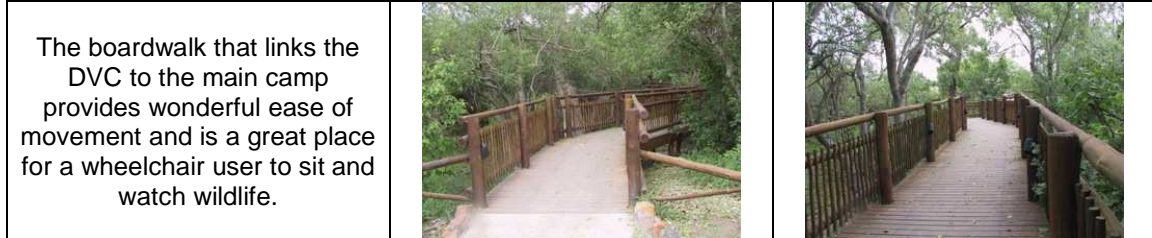
The **Letaba (Mbavala) Day Visitor Centre (DVC)** that adjoins the camp but is intended for use by non-residents of the camp is fairly new and offers fairly good access as the underlying pictures will show. A wide, firm and smooth pathway takes one from the parking area down to the facility. Among the picnic tables some of the paths are a bit gravelly.

The tables are not superbly designed to allow clearance for a wheelchair users legs, but with an angled approach can be used.

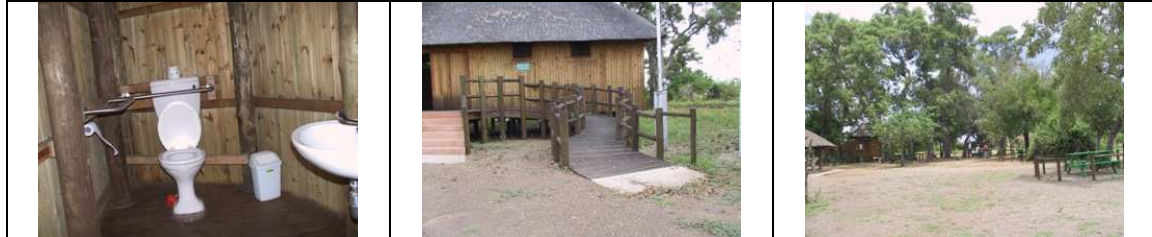
Makhadzi Picnic Site and Steinhecker's Horse Museum (Below) is +-35km from Letaba, and an excellent destination for a morning or afternoon drive. It is on the road to Giriyondo Border Post into Mozambique and the creek just before one gets to the picnic site is an excellent oasis in the rather monotonous mopane woodland that typifies the drive. Hippo should be seen in the creek and there is almost always interesting game in the area (especially the rare tsessebe). There is an accessible toilet here (left) and the museum (centre) is fitted with an access ramp. The picnic site (right) is flat so wheelchair users can move between tables, although the ground is sandy in places, there is a threat of thorns and after heavy rains things can get muddy.

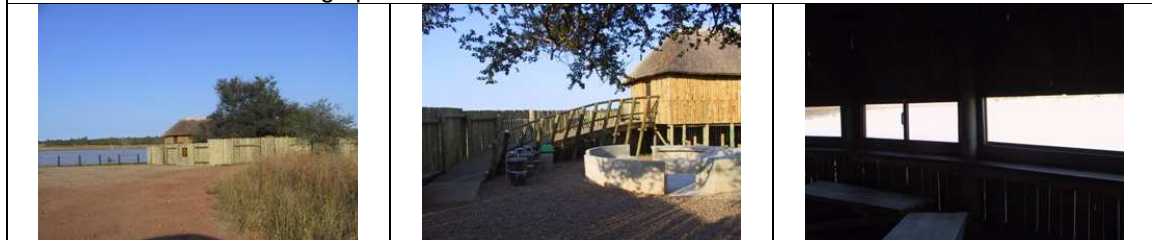
Sable Dam Hide (below) is +- 45km from camp on the Phalaborwa Road is a good destination for wildlife activity and an ideal morning or afternoon drive from camp or a place to stop in transit on entering or leaving the park at Phalaborwa Gate – the hide has a long and steepish ramp to allow wheelchair users to enter the raised platform of the hide and inside it is comfortable to use the viewing slots with mobile benches and a shelf for resting ones elbows on while using binoculars. There is a toilet at the facility that has a ramp and can be entered, although there are no grab rails and insufficient turning space.
