Pretoriuskop Rest Camp, Kruger National Park – Access for Guests with Mobility Challenges

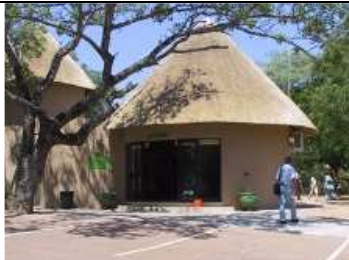
The camp's reception has a handful of demarked bays, one of which is marked for wheelchair use. Entrance to reception is up steps, but there is an alternative entrance with no steps that guests in wheelchairs can use. There are public toilets including an accessible one round the back of the reception block

The reception's accessible ablution facility is useable, but the basin is a little far from the toilet, which is rather low and the adjacent grab rail is fixed at an angle.

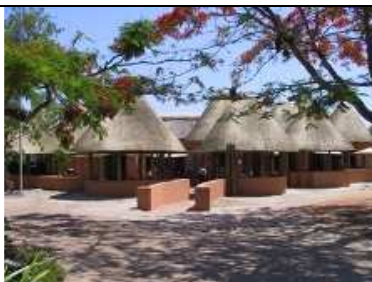
The camp's cafeteria and restaurant have good access and while there is a small section of the indoor portion of the restaurant that is up steps (where the bar is located), the rest of the facility can be used with ease and comfort. The camp shop is fully accessible with ramped access and wide aisles inside.

There are suitable accessible ablutions between the restaurant and the shop complex. The grab rails are correctly position and the basin is within reach of a person seated on the toilet.

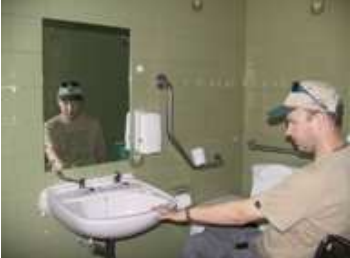
<p>The facility's basin has good clearance, push taps are provided and the mirror is well positioned. The toilet is in a good place for users to access the basin while on the toilet and the grab rails are in the correct position</p>

<p>The facility's shower however is somewhat cramped being a three wall design and the detachable hand shower is of an old and poor design and could be replaced by a better one.</p>
