## Punda Maria Camp, Kruger National Park - Access for the Mobility Impaired

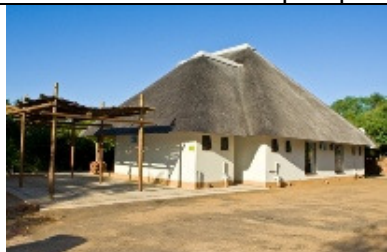
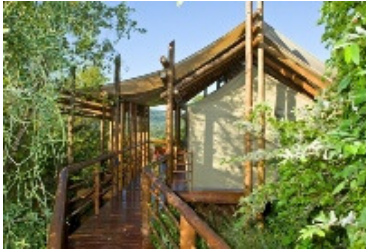
The **Accessible Family Cottage** (below left) can sleep 6 people. The unit has ramped access. There are 3 bedrooms (one upstairs) and 2 bathrooms, one of which is converted for use by guests with mobility difficulties. This bathroom contains a toilet with grab rails and a roll-in shower with a height adjustable, detachable shower. A support grab rail needs to be inserted in the shower on the side wall. The unit has an open plan kitchen and a lounge with DSTV.
