Satara Camp, Kruger National Park

Access for Guests with Mobility Challenges

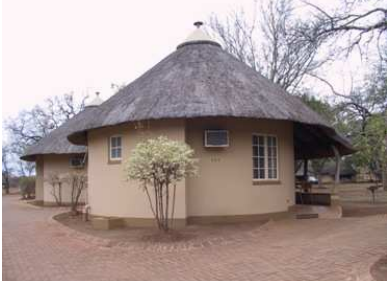
<p style="text-align: center;">One of the C-Circle Accessible Bungalows</p>

<p>The parking space provided for the C-Circle units is standard width and a vehicle with a wheelchair driver or passenger will need to park to one side to provide enough space for the wheelchair to avoid the curb.</p>
---	--

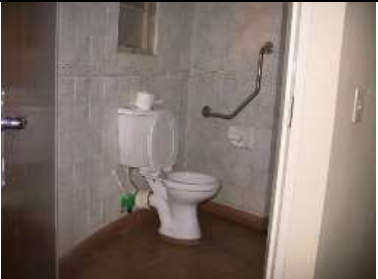
<p>The unit's toilet has an adjacent grab rail on the perpendicular wall, but not one at the rear of the toilet. There is also no water source within reach of a person sitting on the toilet with the basin being located in the bedroom part of the unit and the shower around the corner.</p>
---	--

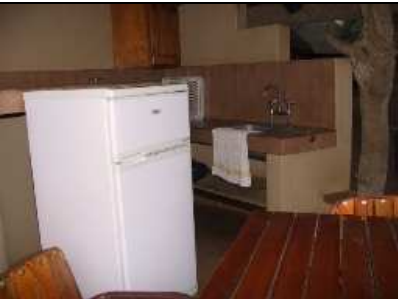
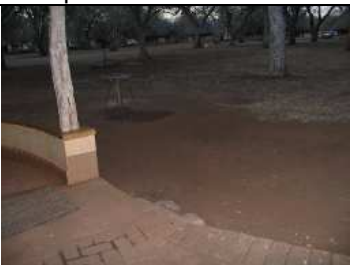
<p>The current fridge on the veranda of the unit is too tall to fit into the provided space and hence it blocks the way of a wheelchair user to get to the sink. There is also a problem in the camp (as with many Kruger camps) with baboons and monkeys raiding the fridges when guests are away from their units. There is sufficient space inside the unit and it would perhaps be an idea for the camp authorities to relocate the present fridge inside the unit to create space on the veranda</p>

<p>The access to the braai (barbecue) facility of the C-Circle units is down a step that has been created over the years by rainfall erosion. This is not in keeping with the accessible intention of the unit and the camp management needs to attend to this shortcoming.</p>	
<p>Satara Accommodation – B-Circle Accessible Bungalows</p>		
<p>The two accessible bungalows in B-Circle (46 and 47) have a reservation code of BD2ZB which suggests they only have 2 beds, but they each have 3 single beds in their bedroom chamber. These bungalows have a shallow access ramp from their parking zone which is wide enough to allow a wheelchair to disembark on either side of the vehicle but not on both at the same time.</p>

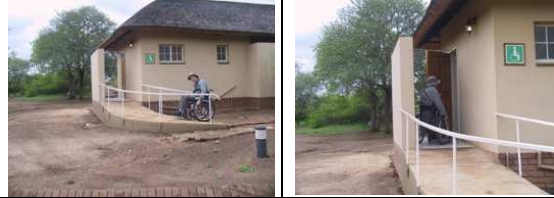
The **northerly accessible campsite ablution** has some uneven open gravel to negotiate to get to, but as one approaches the facility there is a concrete ramp with protective rails allowing a wheelchair user to get right up to the entrance door

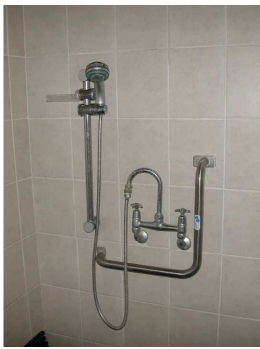
This ablution is only a couple of years old and has some good features, but also some fairly odd features too. The coat hooks (below left) are too high up the wall for a wheelchair user to use to hang stuff on while they use the facility. The basin (below centre left) is fairly accessible, but only has turn taps and the mirror is a little high for wheelchair users. The hand drier (below centre right) has a shelf below it which will be useful for people with balance difficulty. The toilet (below right) has well appointed grab rails, but there is no water supply within reach of a person using it.

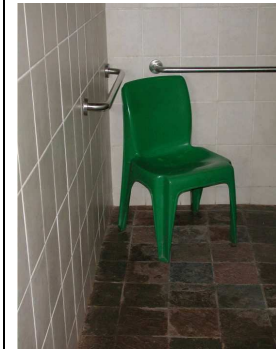
The facility's shower is the biggest area of concern. There are 3 separate grab rails and a detachable shower set on a height adjustable sliding pole. But there is no fold down seat for wheelchair users to transfer onto and instead an unstable plastic chair has been provided. 2 of the rails are on the far side of the shower 2 or 3 metres from the shower making them redundant to use. The shower pole is attached to the wall too low to be properly used and the taps are turn taps which will prevent some people from using them.
