West Coast National Park Access for Mobility Impaired Guests

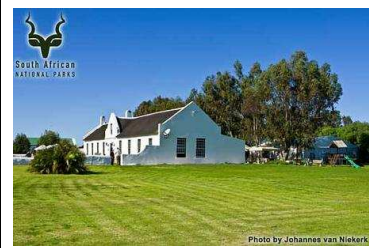
Geelbek Restaurant and Wedding Venue: Geelbek is a historic homestead, operated as a public private partnership. The operator runs by a superb restaurant and wedding venue and there is also an information centre here for historical and ecological information on the park. There are accessible toilets at Geelbek, although the ramp into the facility is short and thus steep and the door is difficult to open from a wheelchair because of the incline. The ramp should be extended and include a level section by the door.

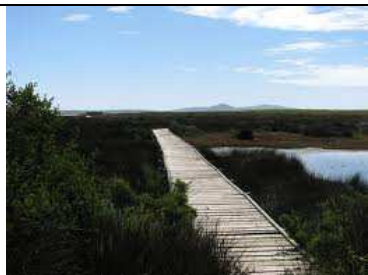
Bird Hides: Another major attraction of West Coast NP is the birdlife and there are 2 hides at Geelbek, but only one is accessible in a wheelchair. This accessible hide is about 300m from the main building along the tar access road. There is then a short distance over open ground before one reaches a considerable boardwalk. This is because of the tidal nature of the lagoon and to cross over the fringing mudflats and pans. There is a small ridge at the start of the boardwalk; but once onto the boardwalk proper the surface should not pose many problems to a wheelchair user. Chairs with small front casters may have to watch the gap between planks in a few places, but the boardwalk has significant kick-plates along both its sides for the duration of the route, so there is never a danger of falling off. Once inside the hide the front section has no benches, so a person in a chair can approach right up to the viewing slot. However the viewing slots on the sides have fixed seating benches in front of them which means these slots are not as convenient to look out of. Another access challenge is that the viewing slots have wooden covers that users of the hide are supposed to close when they leave and no-one else is in the hide. If a wheelchair user is alone this will be a little difficult, particularly where the fixed benches prevent access to the slots.

Start of the long boardwalk to the hide

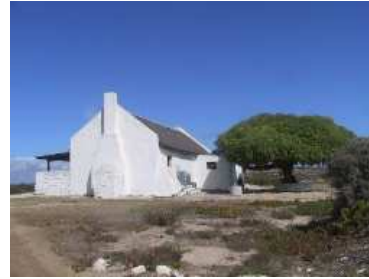
Abrahamskraal Cottage: is a historic Cape Dutch style homestead of great beauty and charm that the park has converted into guest accommodation. The park has had the foresight to make the unit accessible to guests with mobility impairment by providing an access ramp into the building and a ramp into the bathroom and providing enabling equipment with the toilet, shower and basin in one of the bathrooms. However a combination of wear-and-tear and incorrect selection or positioning of equipment means that the unit has a few challenges at present. The park management has been made aware of these and hopefully the images and info will soon be changed for the better.

The first challenge occurs in the erosion of the ramp. In 2007 it was in good condition as shown on the left. However by 2011 it had eroded considerably. Its current condition is shown below left and without help it is not accessible to a wheelchair user. The veranda of the cottage has also received a make-over to include some shade and outdoor tables as shown below. The table of the left of the veranda is too close to the supporting pole to allow a wheelchair to pass, while the one on the right hand side does have sufficient space between the table and support pole so that a wheelchair user can still get to the braai (barbecue).

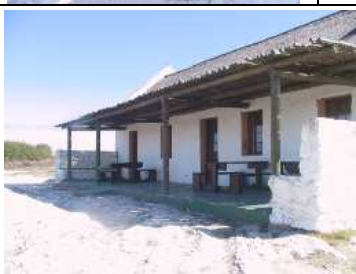
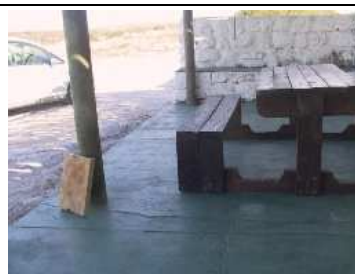
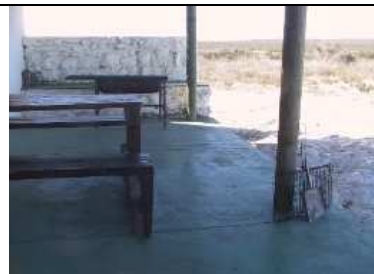
There is a small ridge (right) at the entrance to the cottage but it shouldn't affect anyone from entering. Once inside one enters a magnificent spacious Cape Dutch kitchen (shown from various angles below). Because of the space most of the facilities such as the fridge, stove, fireplace, sink, cupboards and dining room table are relatively accessible without having any enabling adaptations.

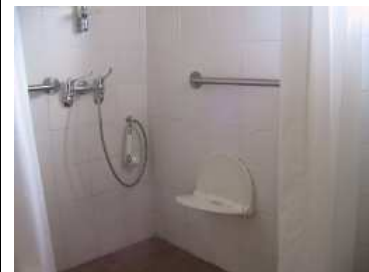
The rear grab rail is a little high and the grab rail on the adjacent wall is attached vertically. This may be fine for frail people to pull themselves upright, but does not help a wheelchair user transfer to and from their chair onto the toilet. This should be an easy thing to rectify. Another shortcoming is that the basin is just too far to be within reach of someone on the toilet.

The roll-in shower is the biggest shortcoming of the ablutions. The seat to transfer onto is not an adequate size to transfer onto (it is actually a foot scrubbing shelf). The rail on the adjacent wall is out of reach and thus no use to transfer or support a wheelchair user, while the one on the wall with the seat is also in the wrong place and would interfere with a person if the seat was large enough to sit on. All these elements are easily resolved and hopefully a fully functional shower will soon be available. In the meantime a dining room chair is a viable option. The shower head is shown loose in the image on the right, but it can be attached to a height adjustable sliding pole so that standing people can also use the facility and seated people can balance themselves while they shower.
